Fiber Reinforced Furan Pipe & Fittings Inspection and Imaging Using Evisive Scan™ Technology

Fiber Reinforced Furan Pipe & Fittings – Prepared Coupons

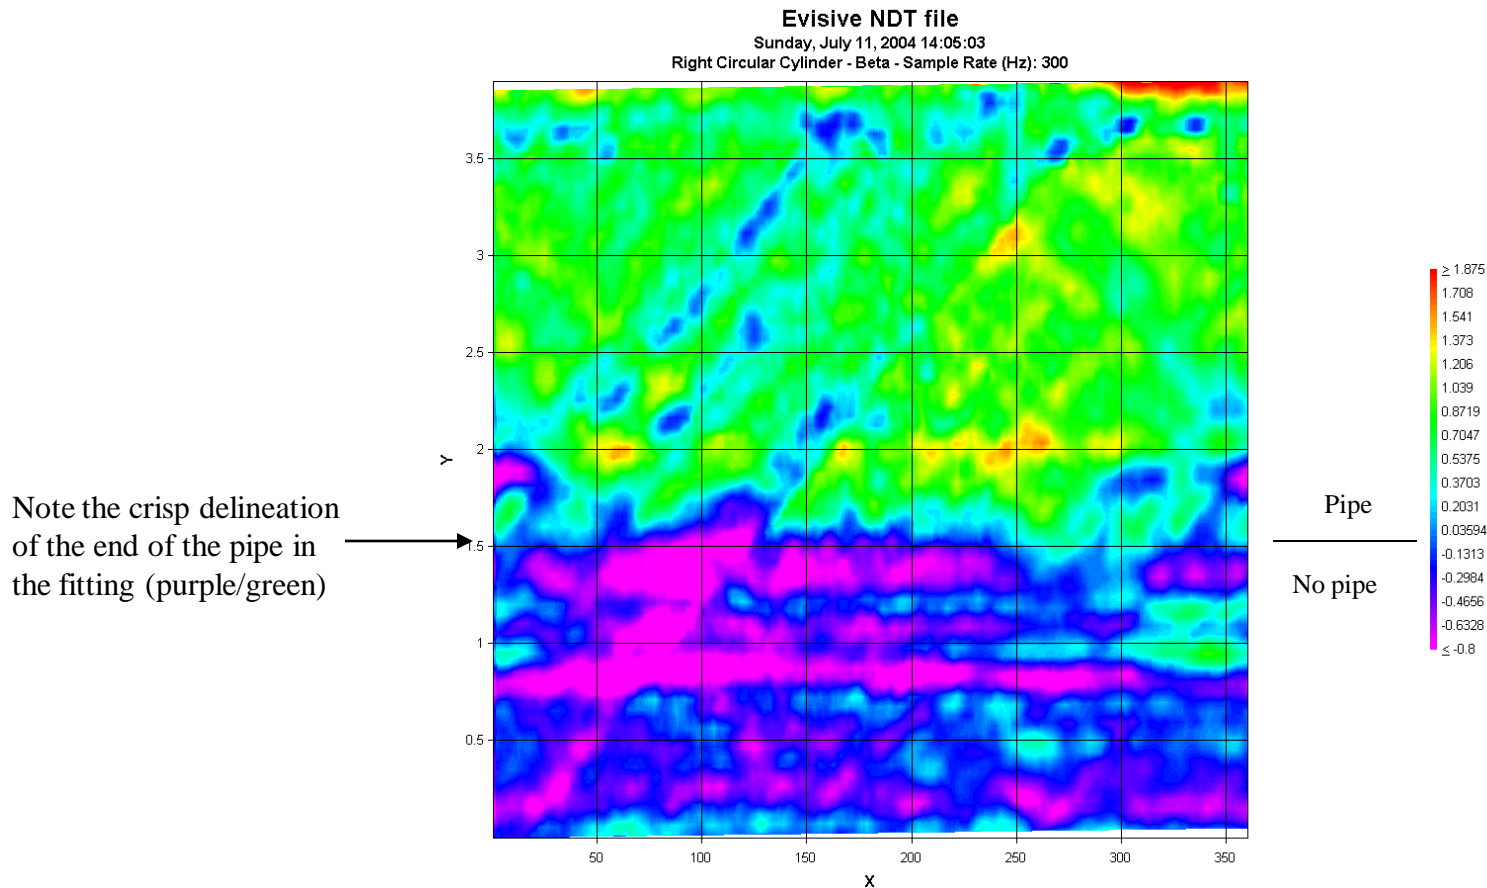
- Pipe coupling joint control standard (no defects)

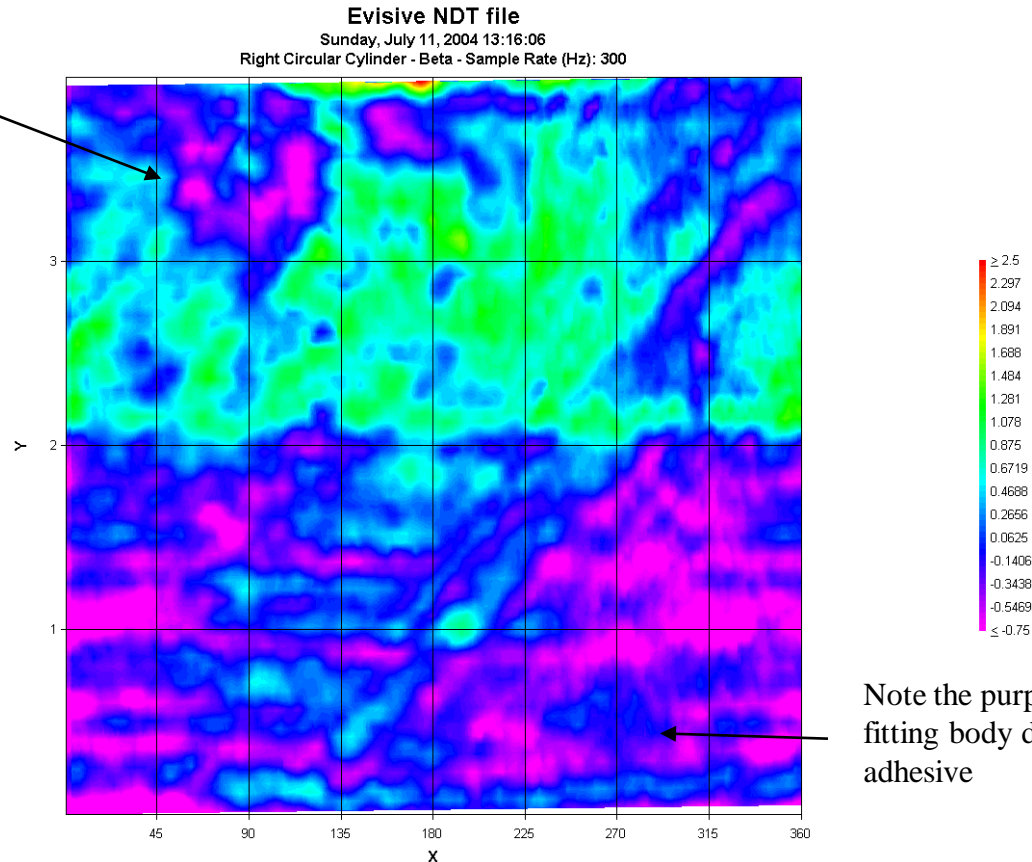
- Pipe coupling joint with insufficient adhesive

Note the purple areas in the fitting body due to lack of adhesive

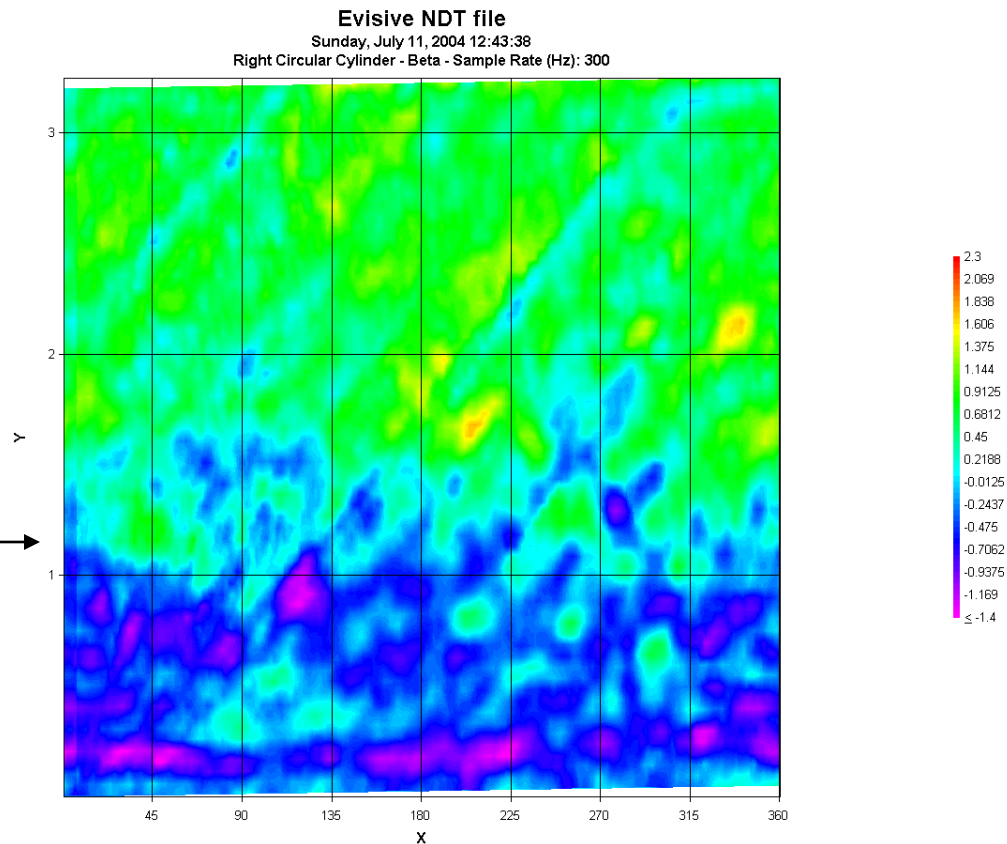
- Pipe coupling joint with excessive adhesive

Note the “sloppy”
delineation at the end of
the pipe, due to excess
adhesive in the fitting

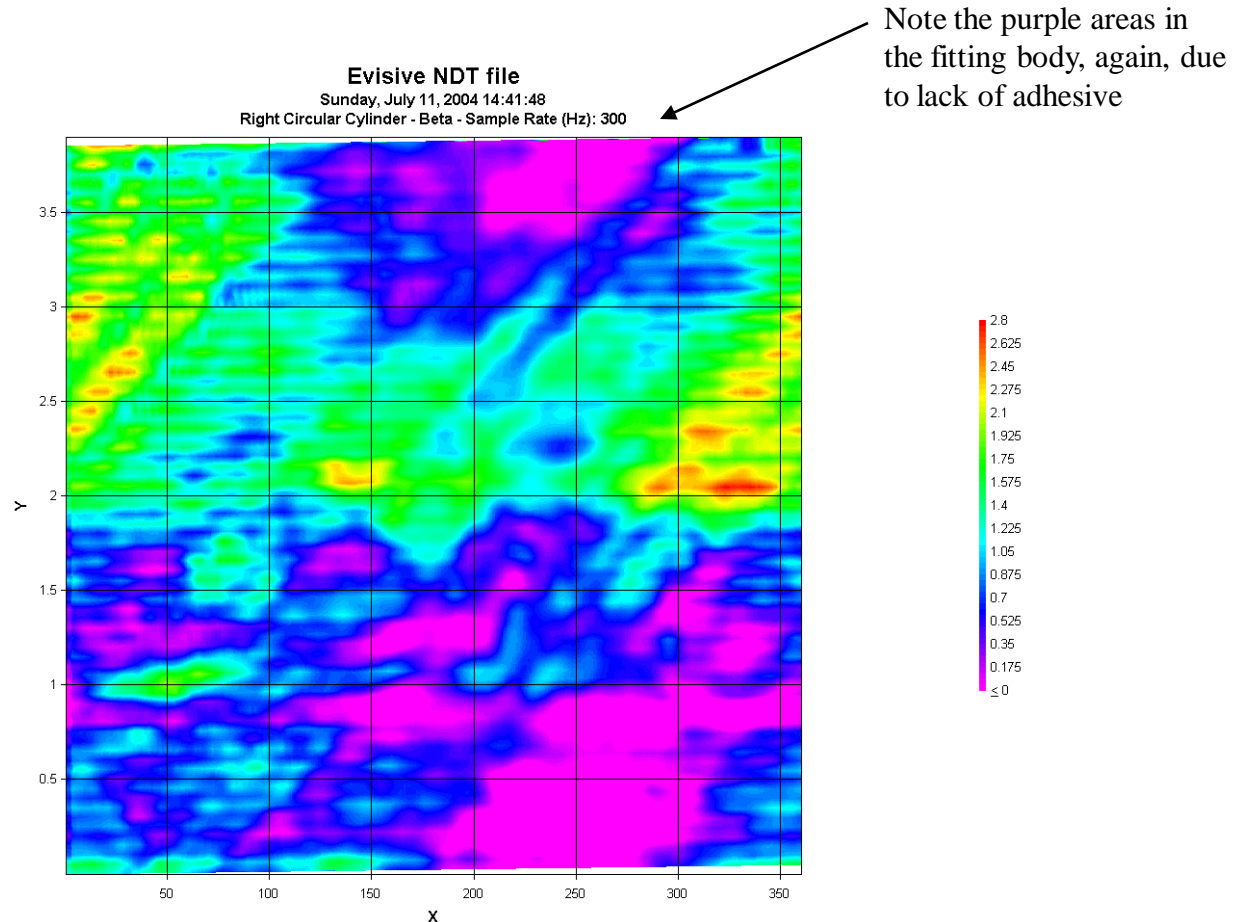
- Pipe coupling joint with adhesive which has been allowed to over-cure prior to its use

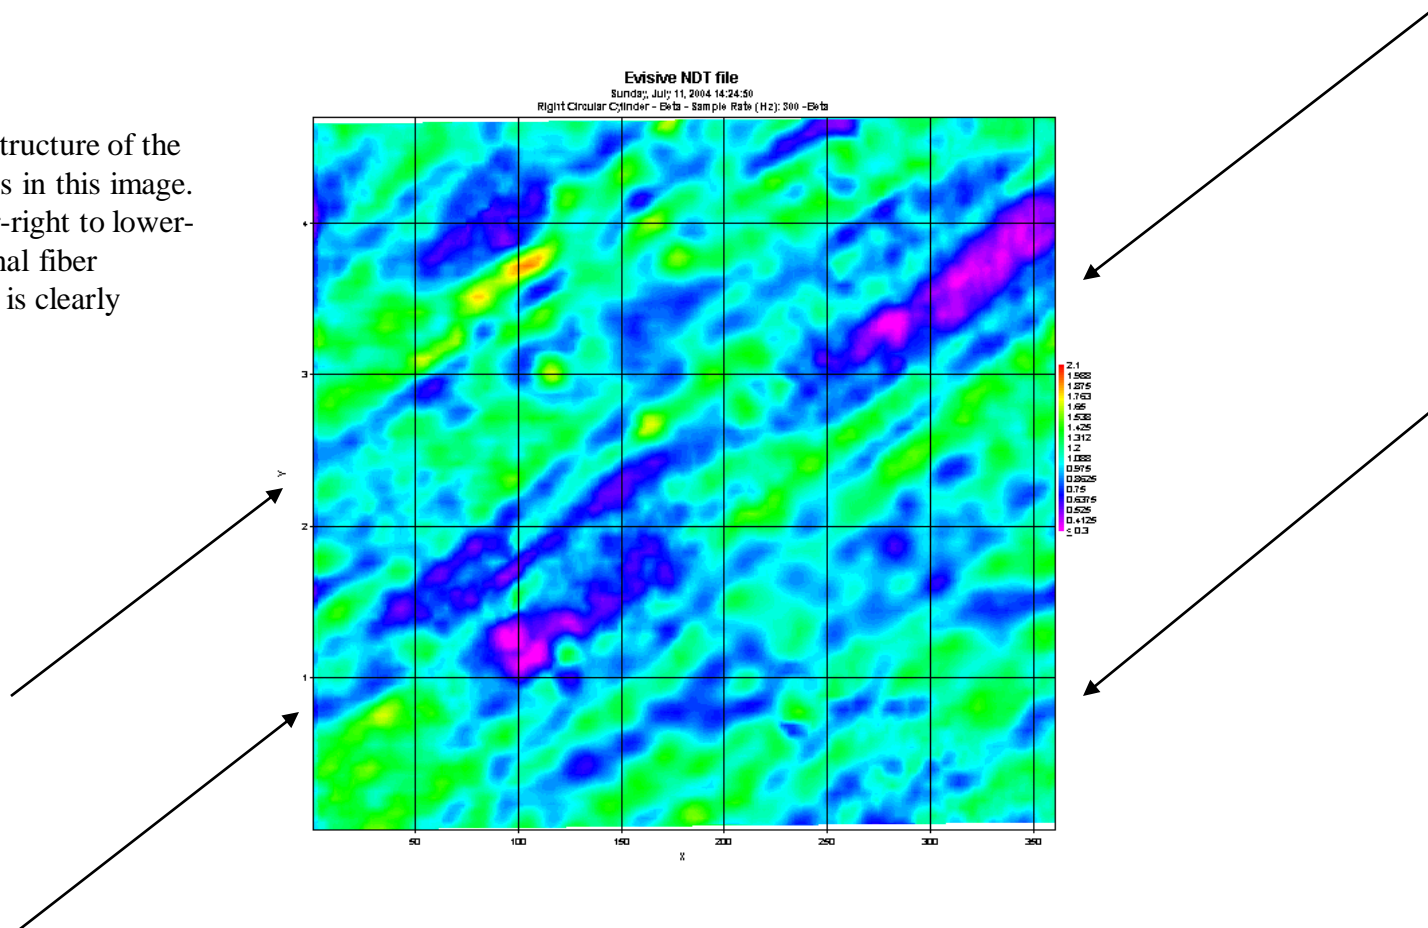
- Pipe section control standard (no defects)

Note the structure of the glass fibers in this image. The upper-right to lower-left diagonal fiber alignment is clearly visible.

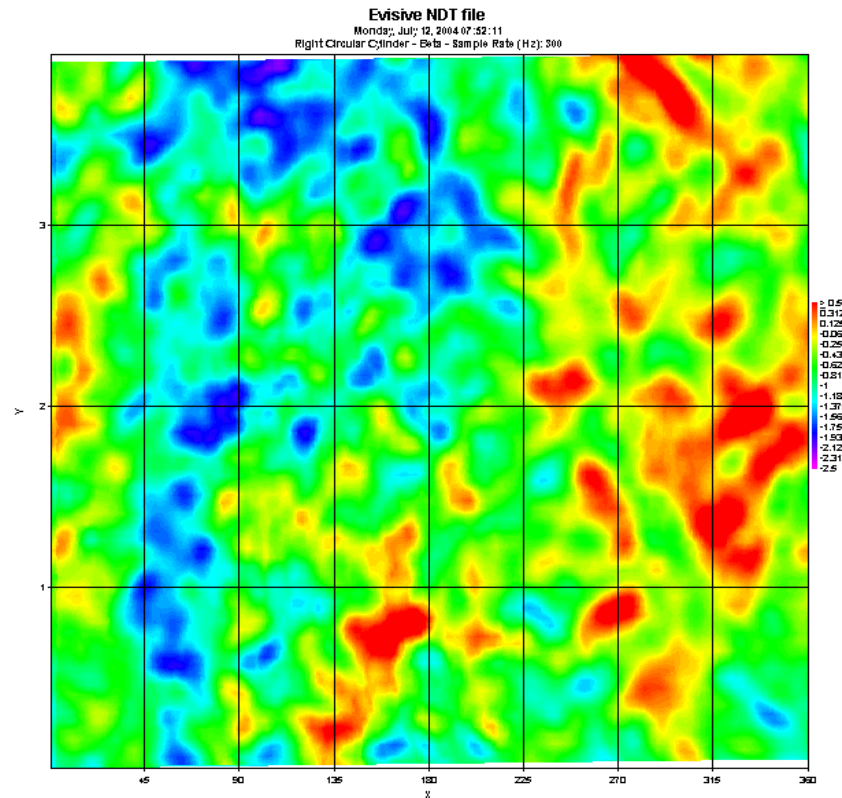
- Pipe section with defects (loss of wall integrity)

Note that the fiber alignment, clearly visible in the image of new pipe is almost completely absent here. The random orientation of the remaining glass fibers in this sample dominate this image. The vast majority of the glass fibers here are anchored at one end only, and the ID of the specimen has a “furry” appearance, owing to the loss of resin component.

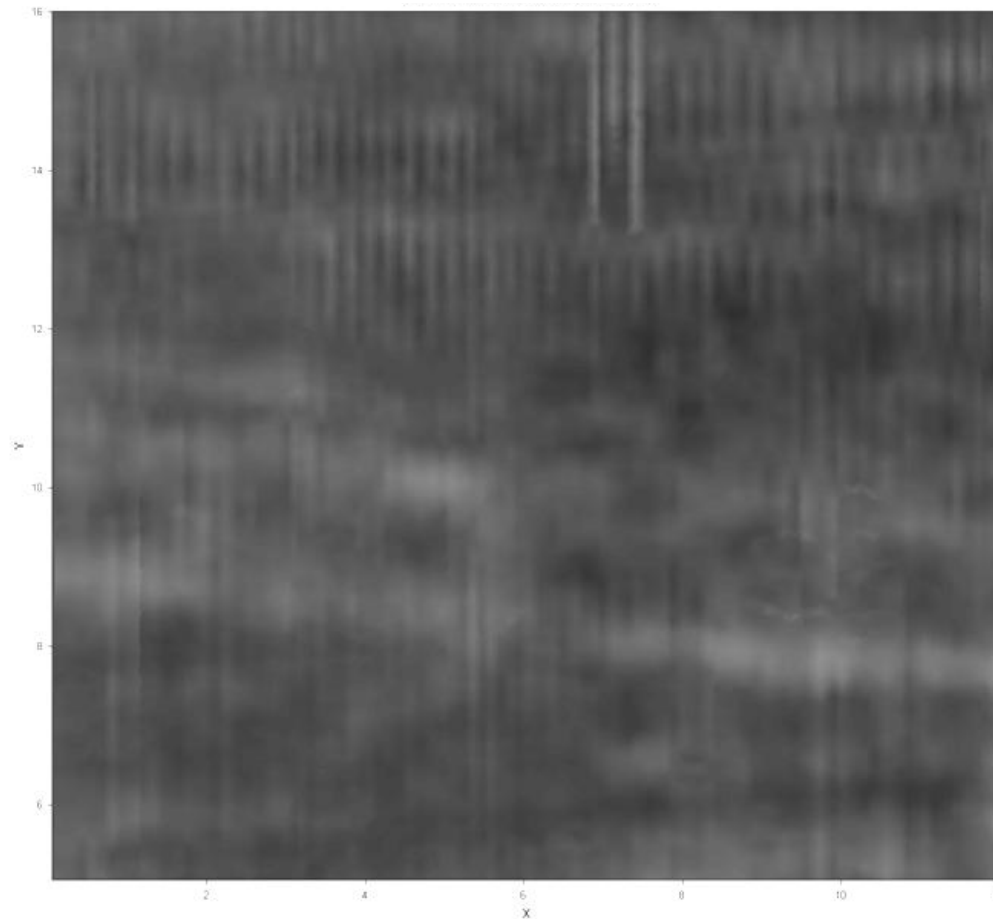
Scan of New Furan FRP Component

Note that this scan is nearly featureless. The only clear features are the diagonals due to the fibers in the composite.

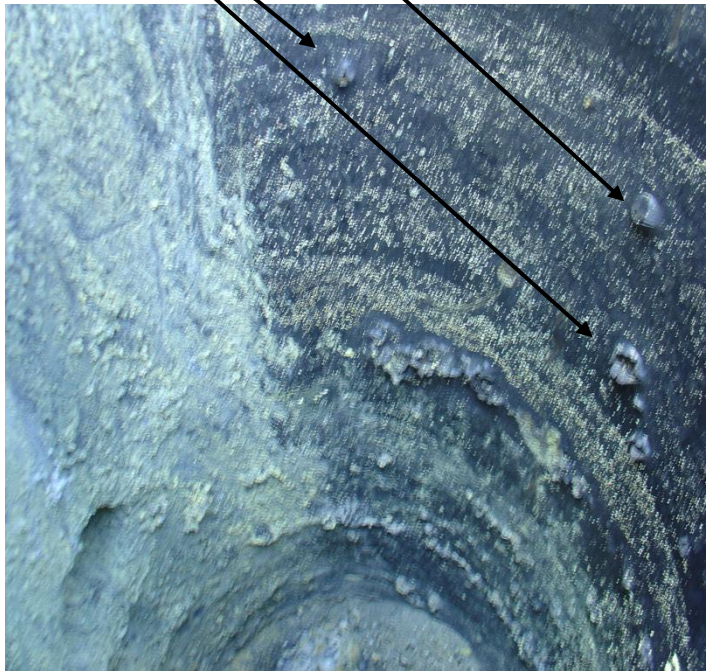
Note the round blisters in various stages of formation throughout the specimen

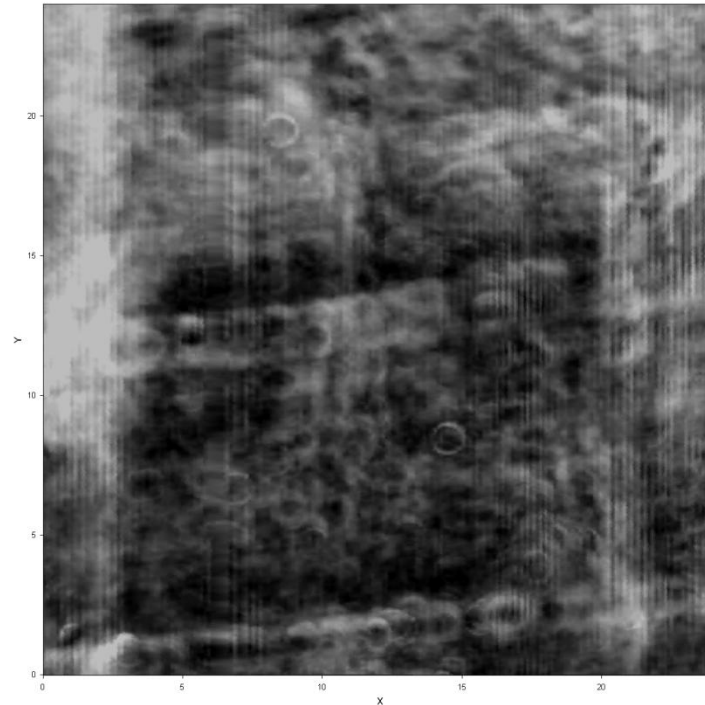
(Validation Scan)

Note the ID blisters, clearly imaged from the OD

Note the areas where the blisters overlap, creating large degraded regions on the ID on both the photo and scan image

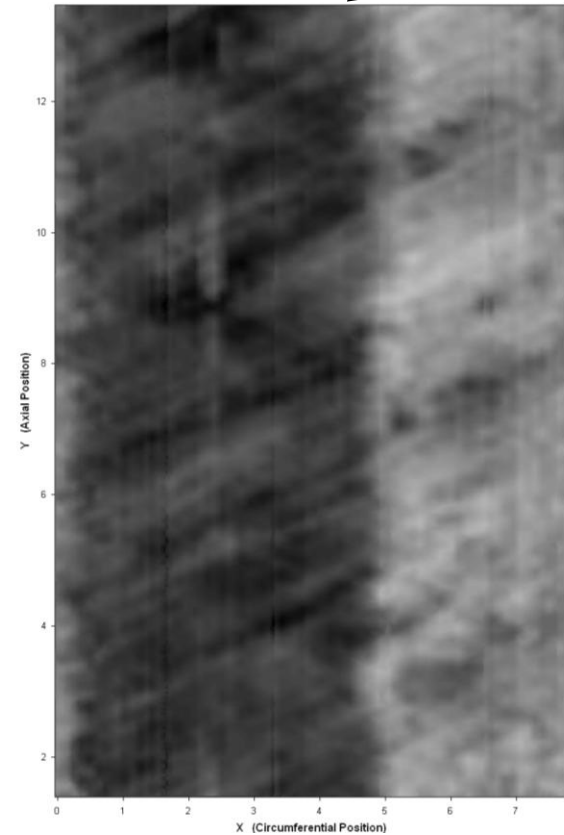
Note the axial line on the pipe ID, indicating that it is degraded over approximately half of its circumference. The resin system has become degraded, exposing the naked fibers.

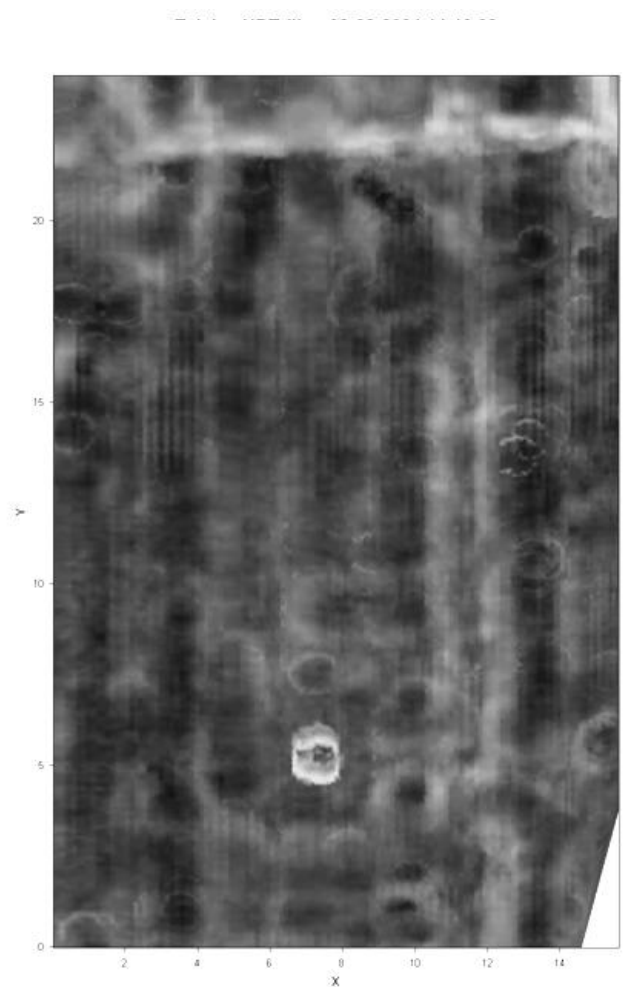
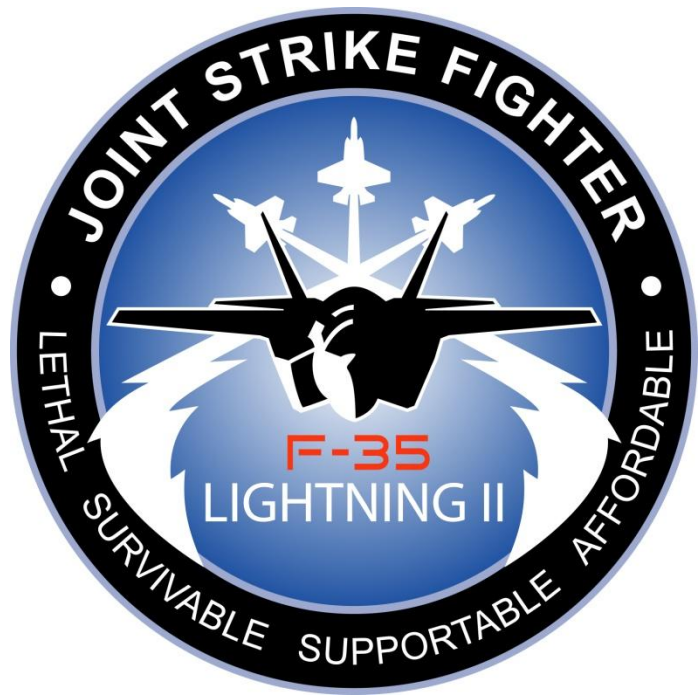
Scan of Component, for Which the Condition Is Unknown

Note the numerous circular indications, very similar to the blister indications in the validation scan
