# HDPE Pipe Electro-Fusion Coupling Inspection and Imaging Using Evisive Scan™ Technology

# Electro-Fusion Coupling

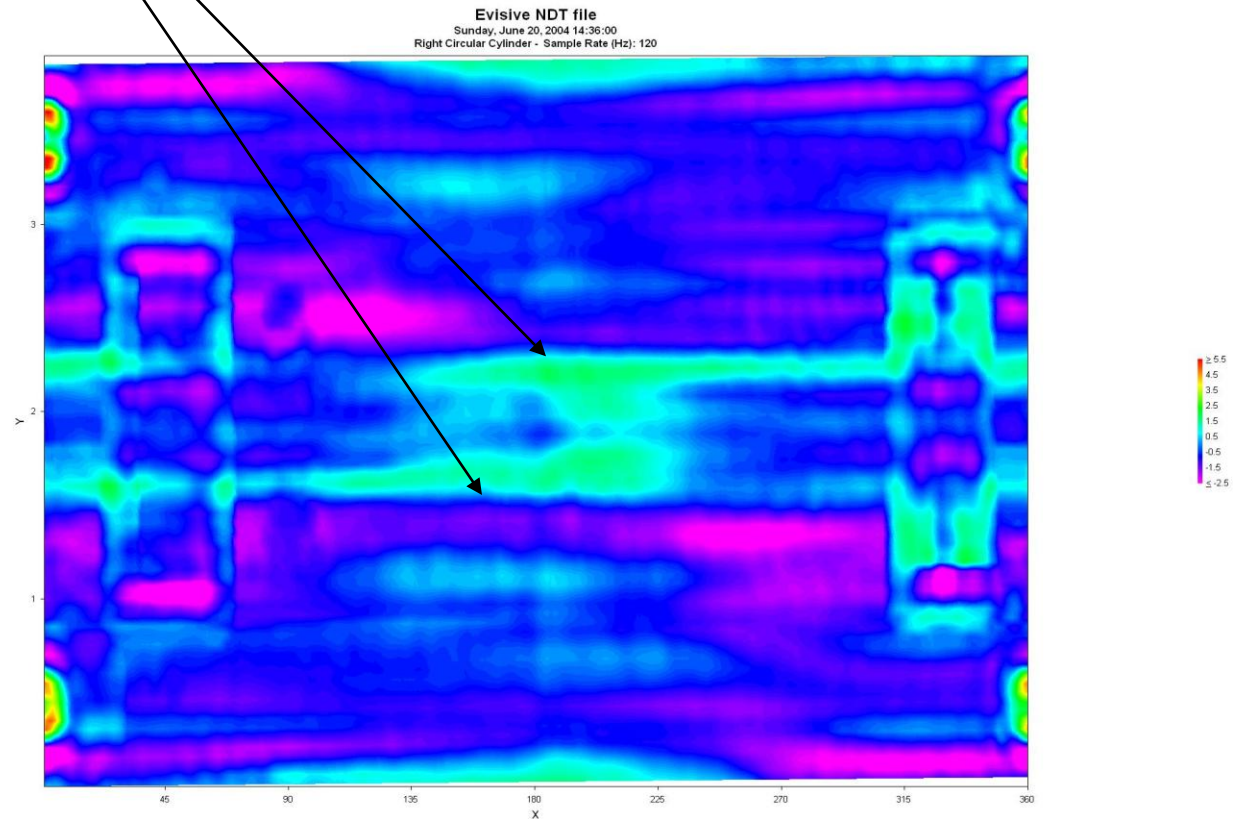
# 4 Inch Electro-Fusion Coupling Proper Insertion

Edges of pipe  
shown at  
proper location

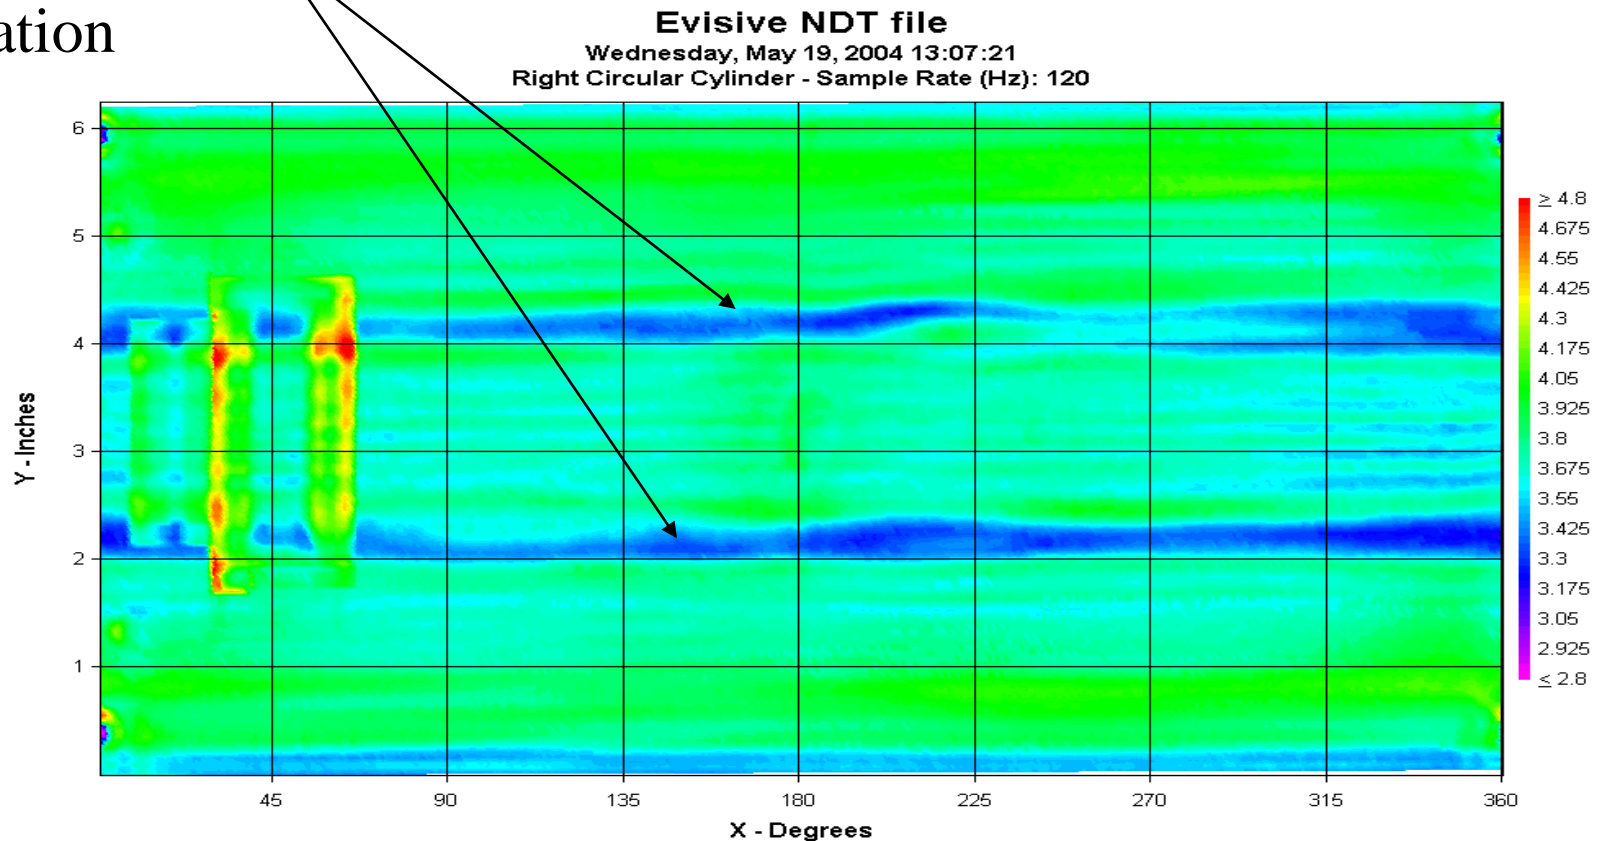
# 4 Inch Electro-Fusion Coupling Poor Insertion

Edges of pipe  
not at proper  
location

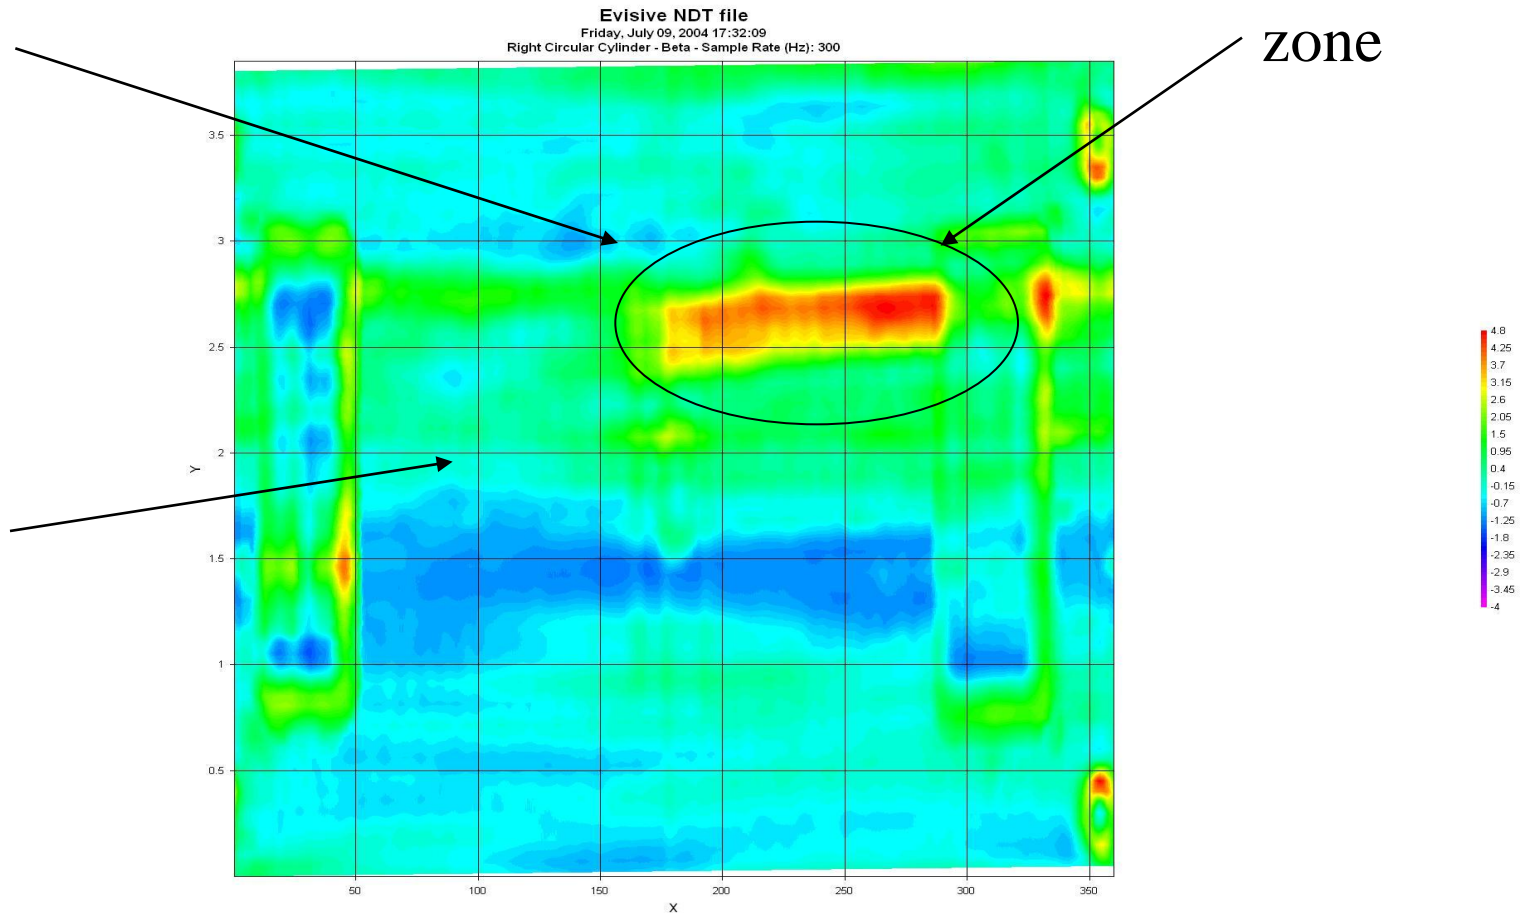
# 4 Inch Electro-Fusion Coupling Poor Insertion w/Melting

Edge of pipe at  
wrong  
location

Edge of pipe at  
correct  
location

Melt  
zone

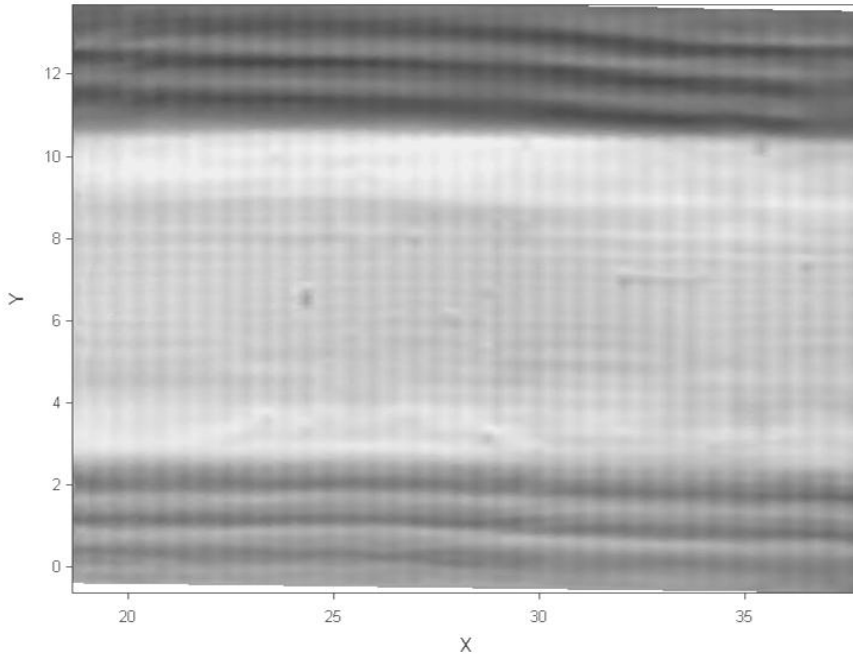
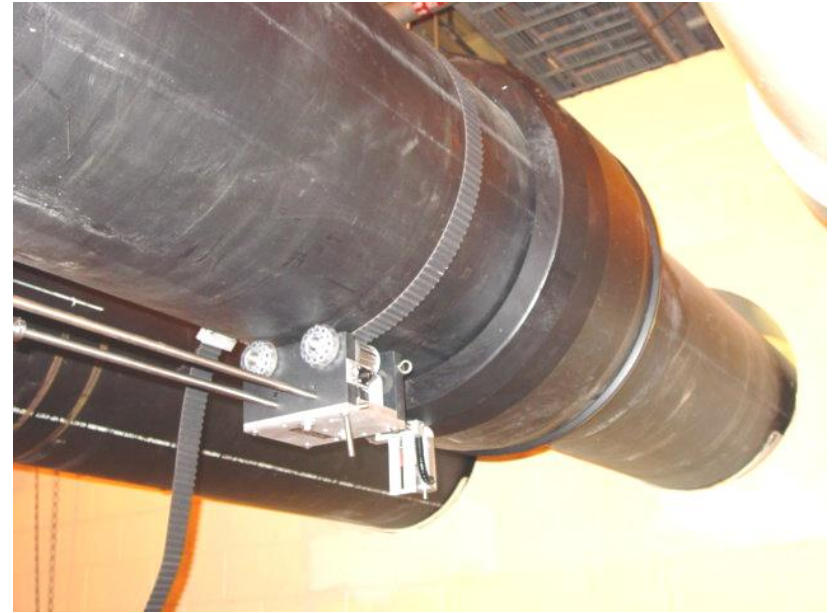
### Evisive NDT file

The scan image at left represents the inspection results for the electro-fusion coupling shown at right. These couplings achieve fusion with the pipe ends by resistance heating caused by passing a precise amount of power through wires embedded in the coupling body. Note the small indication near  $X=24$ ,  $Y=6.5$ . This indication was caused by a small air bubble trapped in the molten plastic, and does not represent a rejectable defect in the electro-fusion coupling installation.
