ICONE17-75742

MICROWAVE BASED NDE INSPECTION OF HDPE PIPE WELDS

Robert Stakenborghs

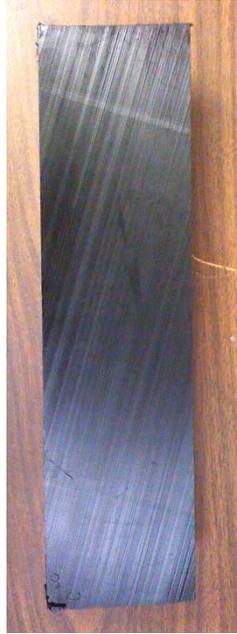
Figure 1
HDPE Weld Block

In order to further understand the microwave technique and its ability to fully interrogate the HDPE weld, a method was needed to determine if the heat affected HDPE material near the weld indeed had properties that allowed the technique to distinguish it from the base material. The most effective way to accomplish this was to scan a defect free HDPE thermal fusion weld that had been machined flat on each surface. This would eliminate any surface features (including weld beads) that might skew the data due to geometry factors. Such a block was fabricated by Acuren and delivered for scanning. The block is shown in figures 1 and 2.

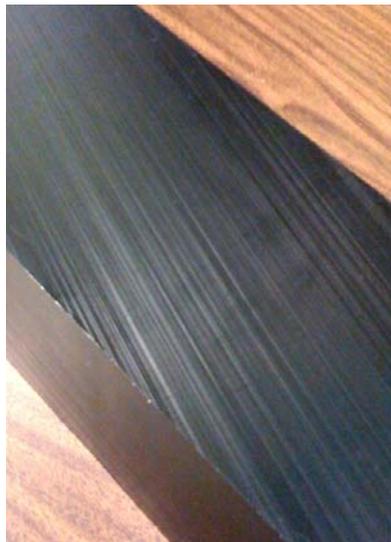
Figure 2
Close-up of HDPE Weld Block Showing Weld Location

The weld was cut out from a thick section of HDPE pipe and shaped into a 3.5” by 4” block. The sides were machined smooth so there are no surface features and no inner or outer beads. Figure 2, the weld close-up, shows that the weld line is barely discernable from the base material.

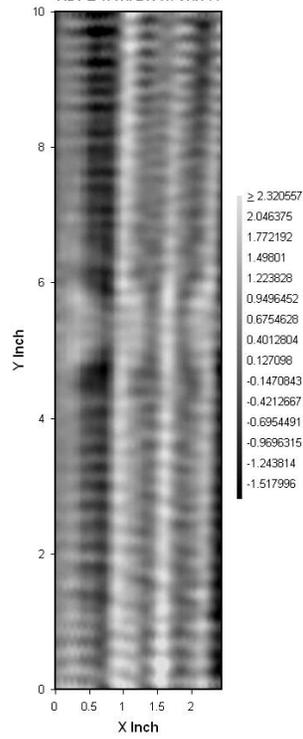
Figure 3
Scan of Side A

As can be seen in figures 3 through 6, the weld material is clearly visible in the middle of the scan. Also, the scans taken on opposite sides of the HDPE block indicate that the weld profile is the same on the opposing sides, but different on the adjacent side. It is expected that the weld heat affected zone profile would be different on the pipe ID and OD (where the

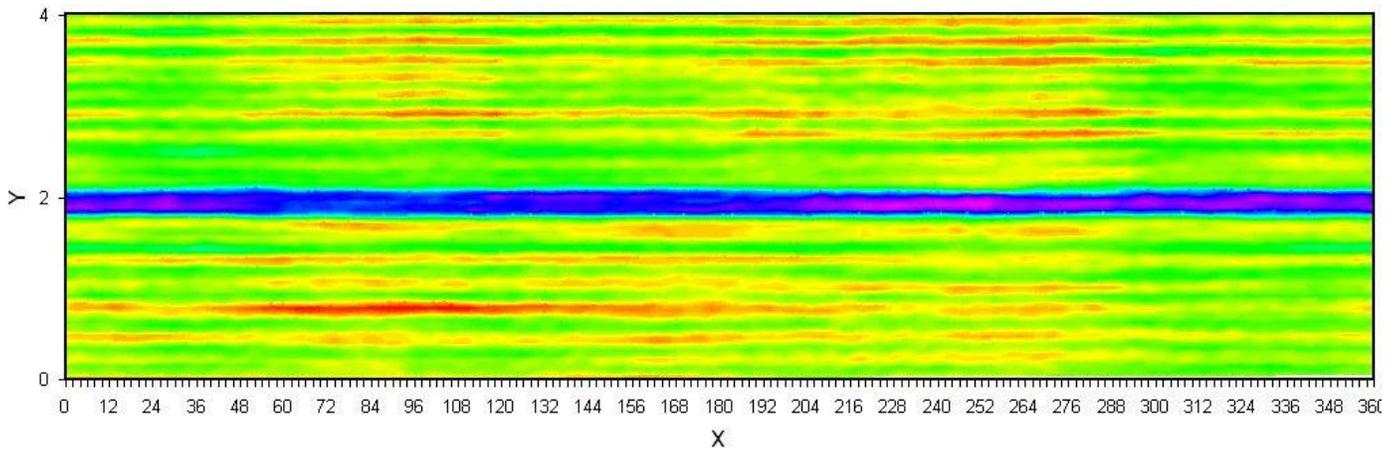
Figure 7 is one example (of many) of a sound HDPE weld scan. In this image, the return signal voltage has been assigned a false color to make interpretation easier. Also, the outer bead has been removed to provide a smooth surface for the scan probe, as is standard for this scanning method. The weld is examined so that the axial direction is on the Y axis and the radial direction is on the X axis. The centerline of the weld is approximately at Y = 2”. The entire heat affected zone of the weld is approximately ¼ “ in width. The horizontal (parallel to the X axis) regular lines are return signals from the inner bead, which was not removed. Note that the weld appears uniform along its entire length and is little return signal (i.e. – voltage) variation.

Fig.	Description
7	Sound weld made per accepted procedure

Figure 7
Microwave Scan of Sound HDPE Weld

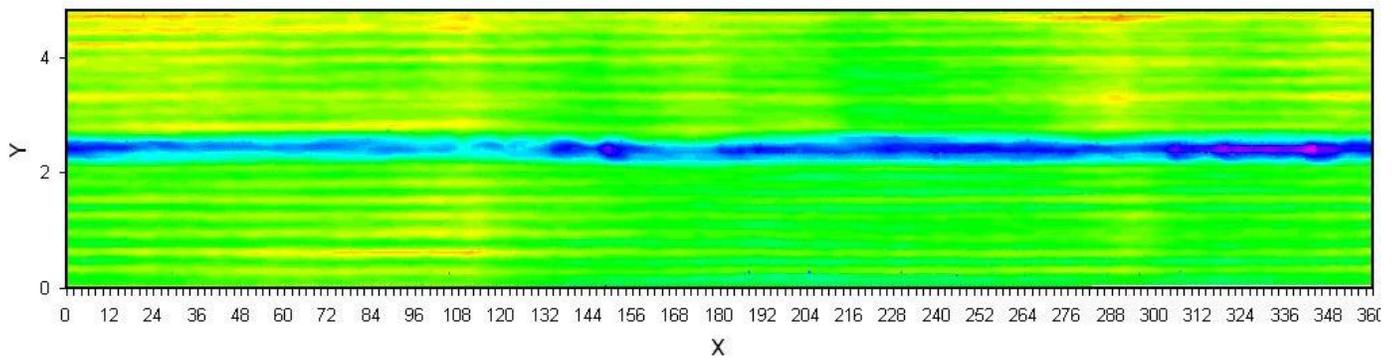
The scan results shown in figures 8-12 indicate that various deviations from standard accepted thermal fusion weld practice result in deviations in the heat affected zone material properties that can be detected by using microwave scanning. Even subtle changes such as a delay time between end of heating and start of fusion can be detected. This likely due to the rapid formation of a “skin” between the weld that has a different microstructure than the normal weld.[5] Also, a weld made with higher than normal fusion pressure can be detected by a change in thickness of the heat affected zone when viewed in the scan. This is simply due to most of the weld “melt” being forced from the joint, resulting in a thinner than normal bonded area.

Figure 8
Microwave Scan of HDPE Weld – 10 Second Fusion Delay

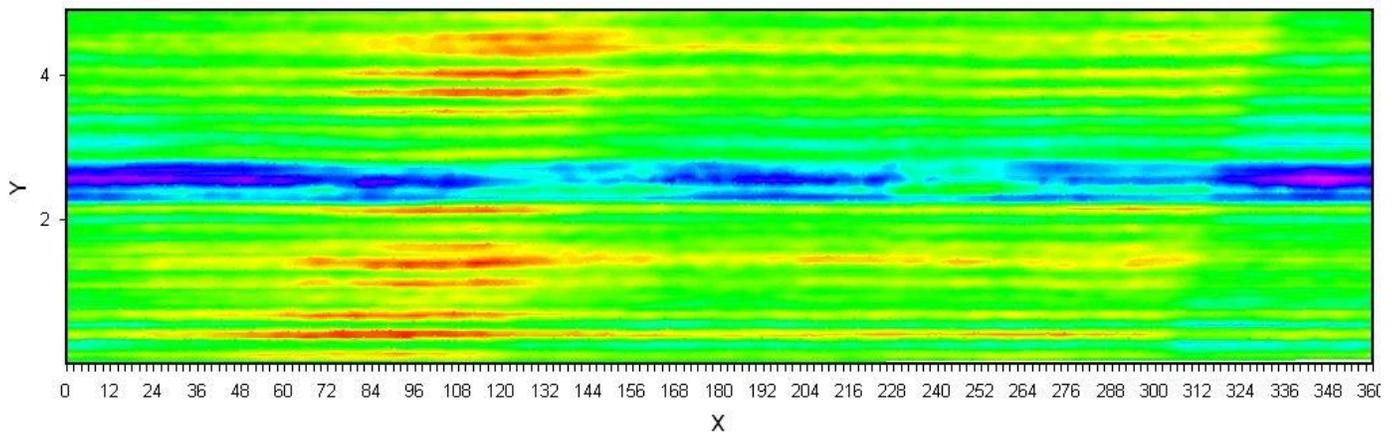
Figure 9
Microwave Scan of HDPE Weld – 20 Second Fusion Delay

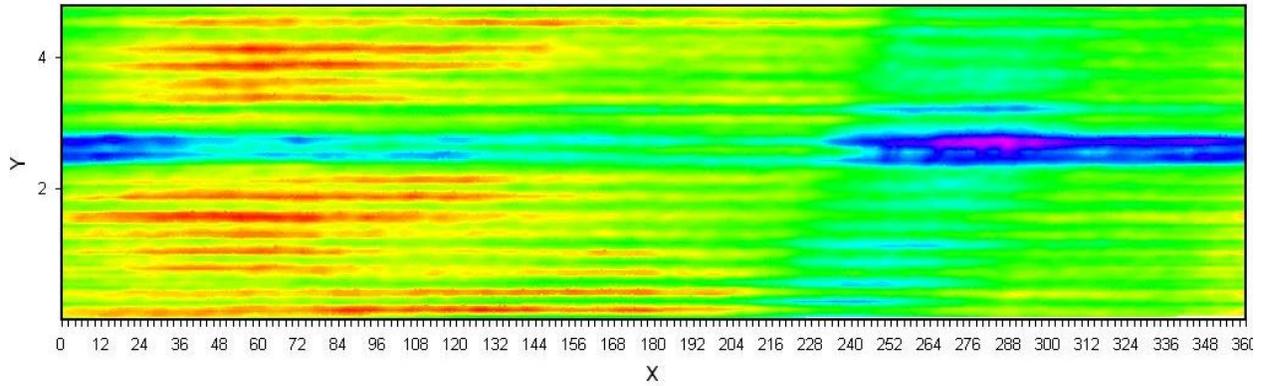
Figure 10

The introduction of various inclusions or contaminants in the weld also resulted in areas where there was a lack of proper fusion, and thus, a detectable difference in the microstructure.

Microwave Scan of HDPE Weld – WD-40 Sprayed on Central Portion of Pipe before Fusion

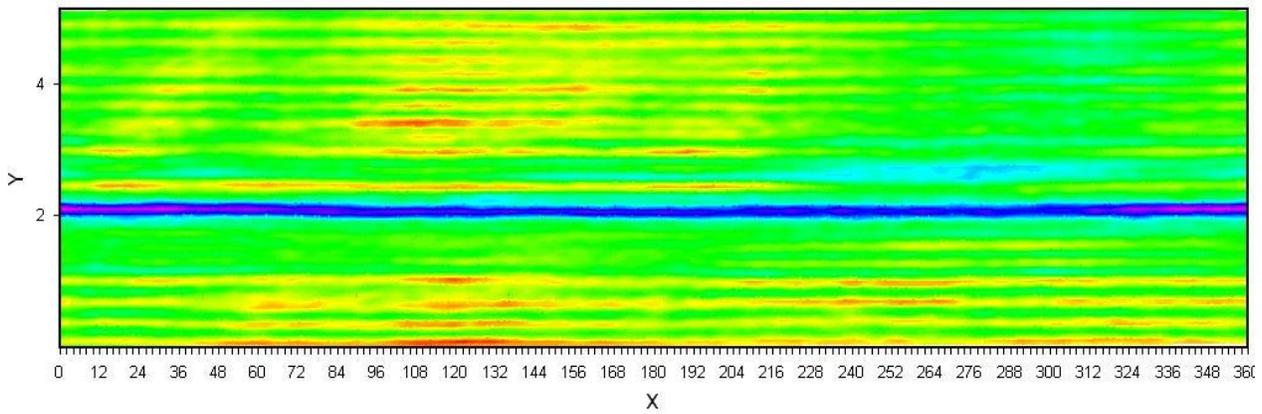
Figure 11

Microwave Scan of HDPE Weld – Assembly Pressure Higher Than Standard

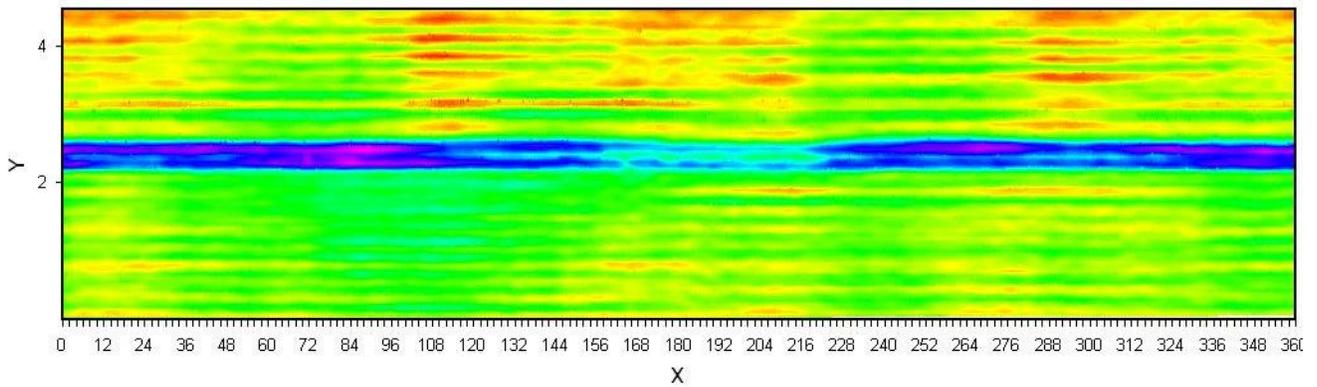
Figure 12

Microwave Scan of HDPE Weld – Cloth Threads Placed on Pipe Prior to Welding
