HDPE Pipe Electro-Fusion Coupling Inspection and Imaging Using Evisive Scan™ Technology

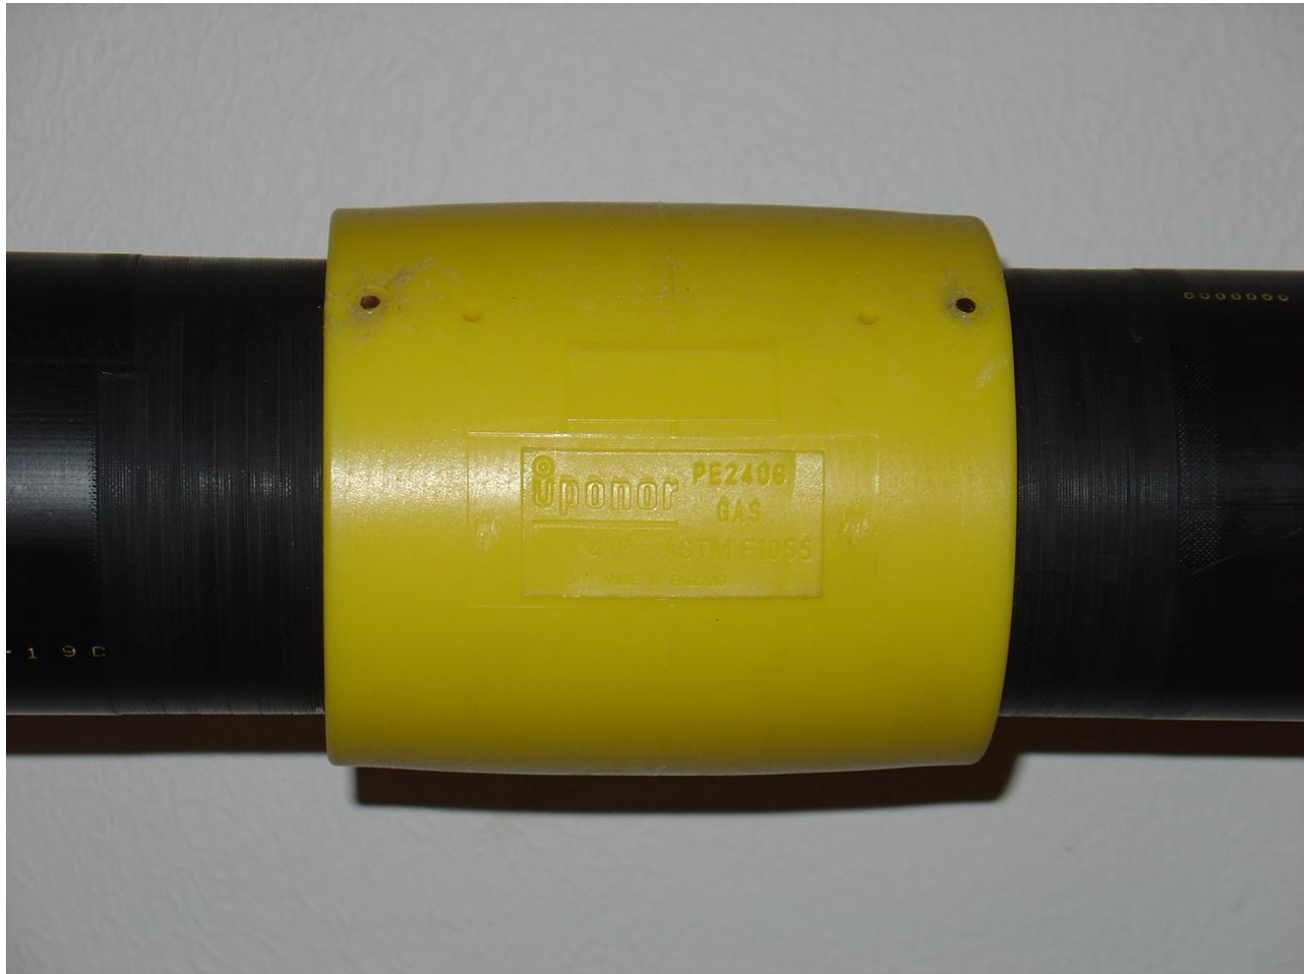
Electro-Fusion Coupling

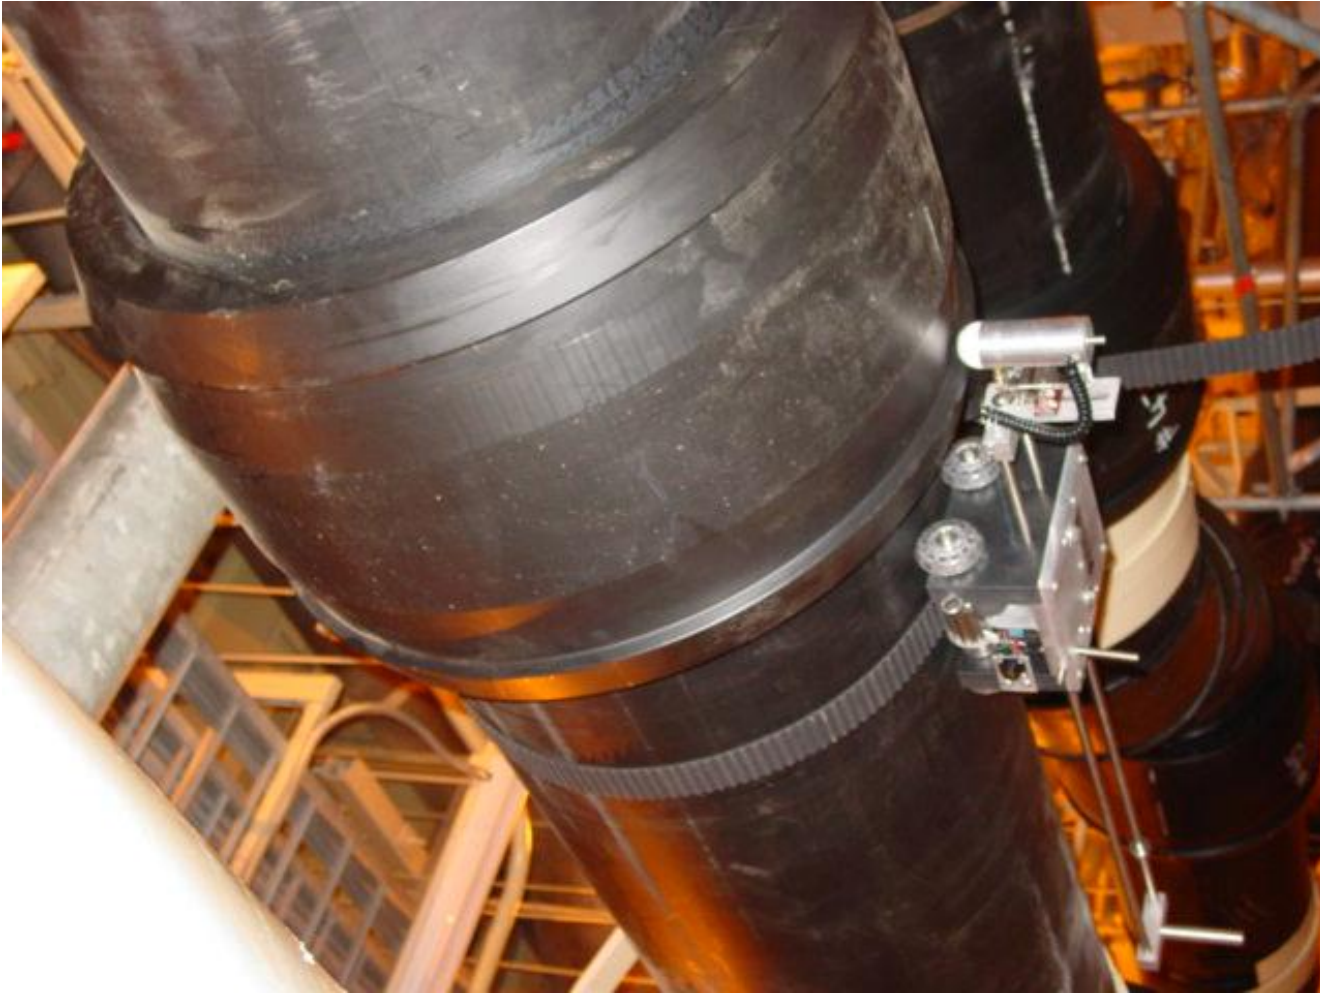
24 Inch PE Pipe Coupling Field Scan

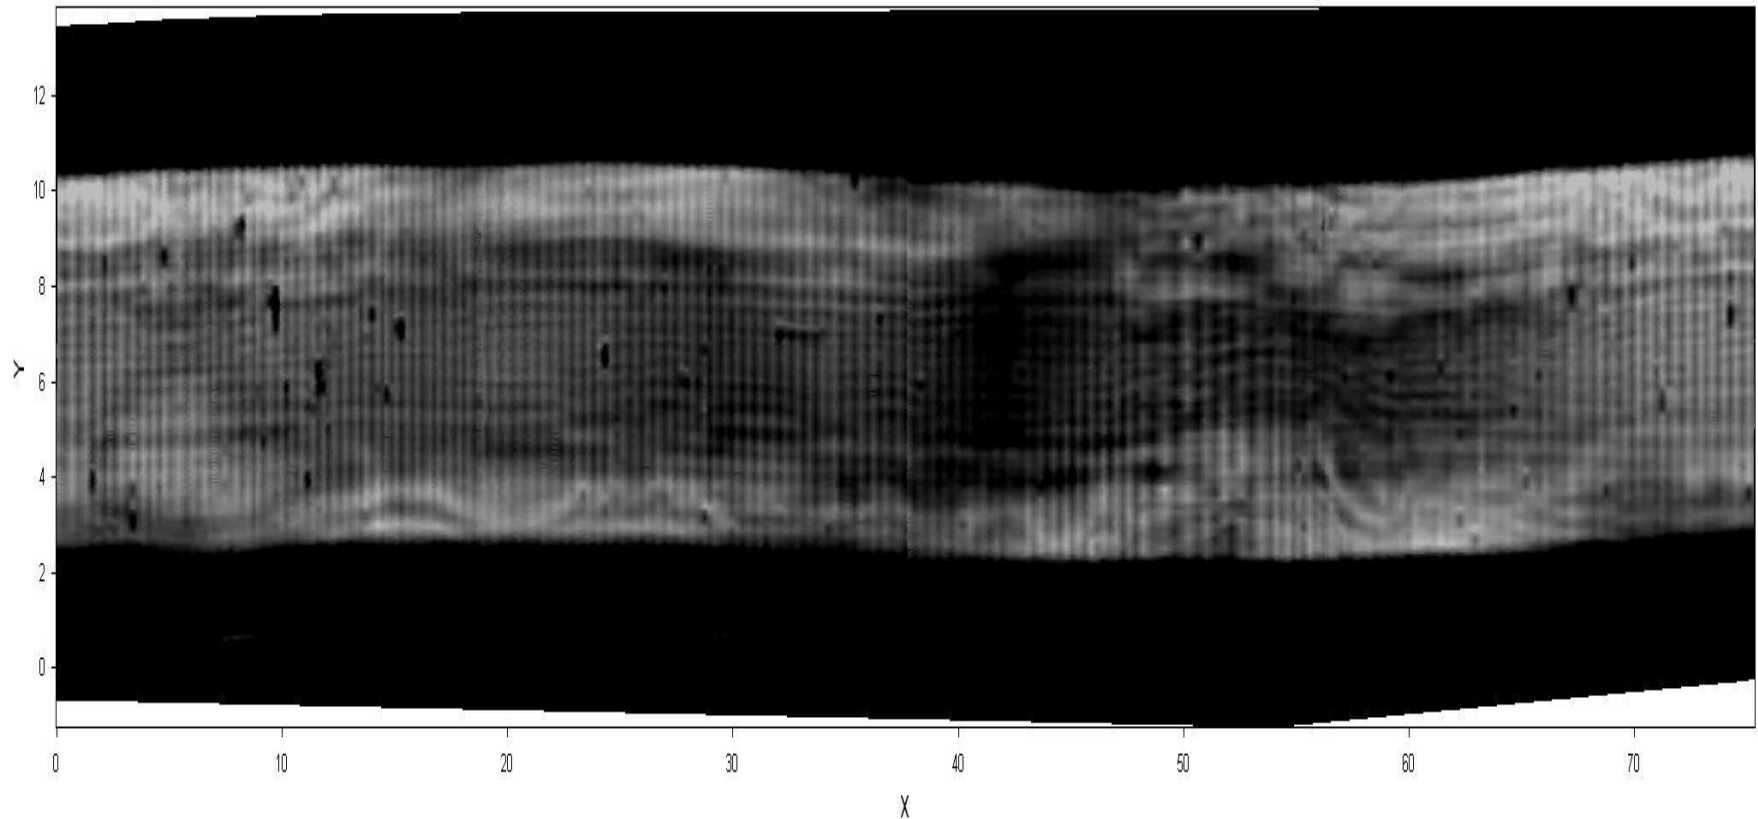
24 Inch PE Pipe Coupling Field Scan

Wednesday, August 11, 2004 17:48:08
X - Y Table (Beta) - Sample Rate (Hz): 100
