Modern Ceramic Structure Imaging Using Evisive Scan™ Technology

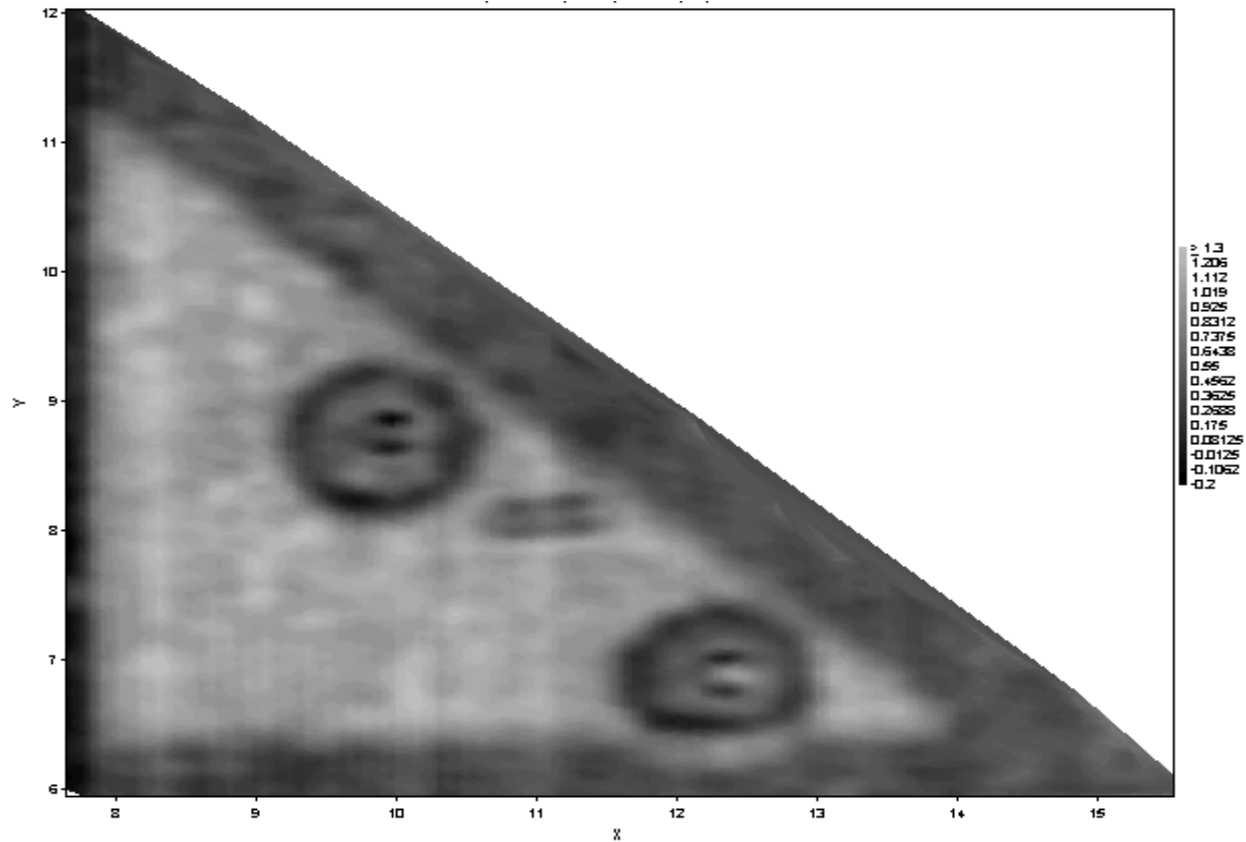
SiC/SiN CMC Coupon Scan

Triangular Ceramic Matrix Composite Fabrication

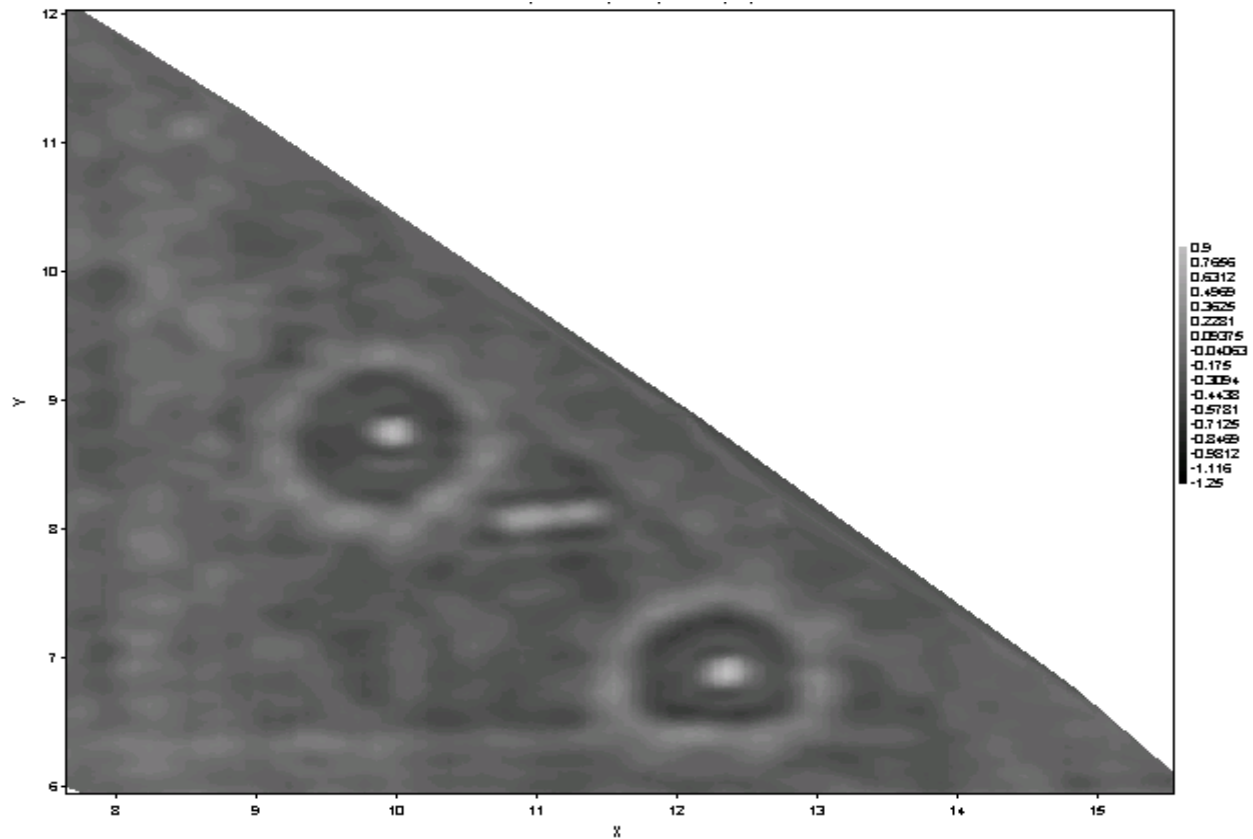
SiC/SiN CMC Coupon Scan

Triangular Ceramic Matrix Composite Fabrication
