Modern Composite Structure Imaging Using Evisive Scan™ Technology

Evisive Scans of Honeycomb Composite Panel

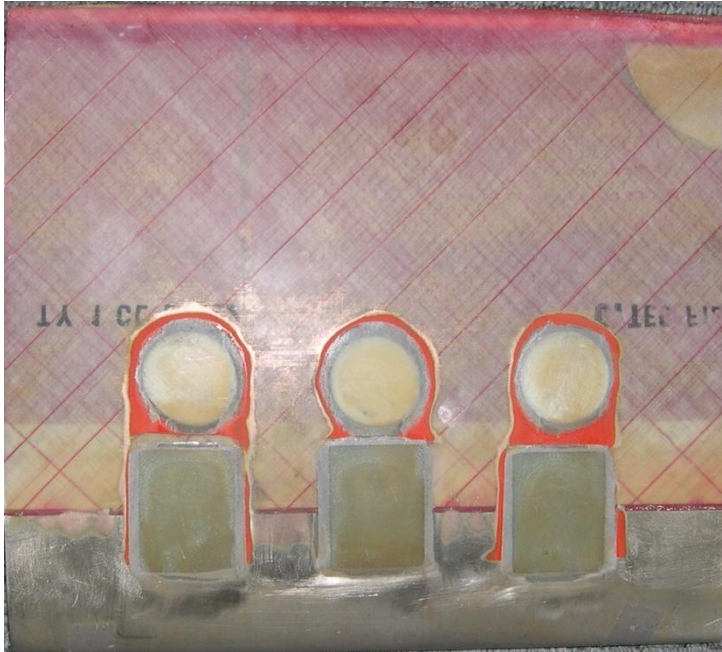
Photograph & Scan Image of Helicopter Rotor Coupon

Above left is a photograph of the coupon. Above right is the scan of this side of the coupon. Note that the defects beneath the round patches on the left and at the center are not simple round holes. The white sections of the black box represent the metal leading edge, and were not scanned.
