Innovative Application Of Microwave Non Destructive Examination Of Composites

Microwave NDE Techniques to Stacked Defects in Laminate Structures

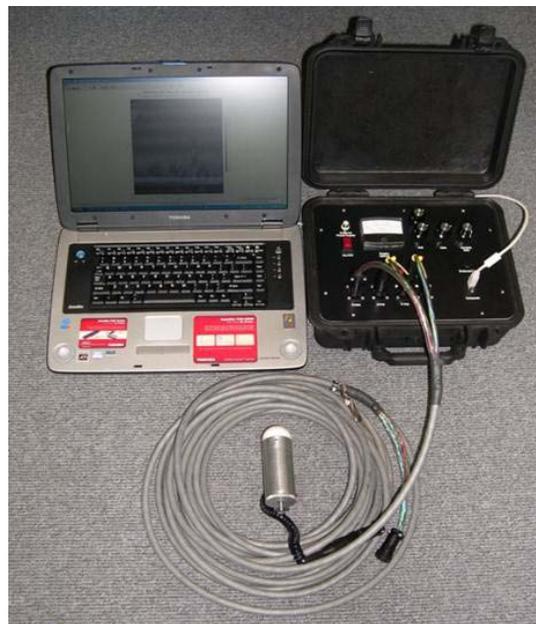
Figure 3: Evisive Scan Equipment

The **Evisive Scan™** equipment is shown in Figure 3. The equipment consists of a microwave probe, processing instrumentation, an interface computer and display, and a probe positioning or tracking mechanism (not shown). Operating, interface and display software resides on the interface and display computer.

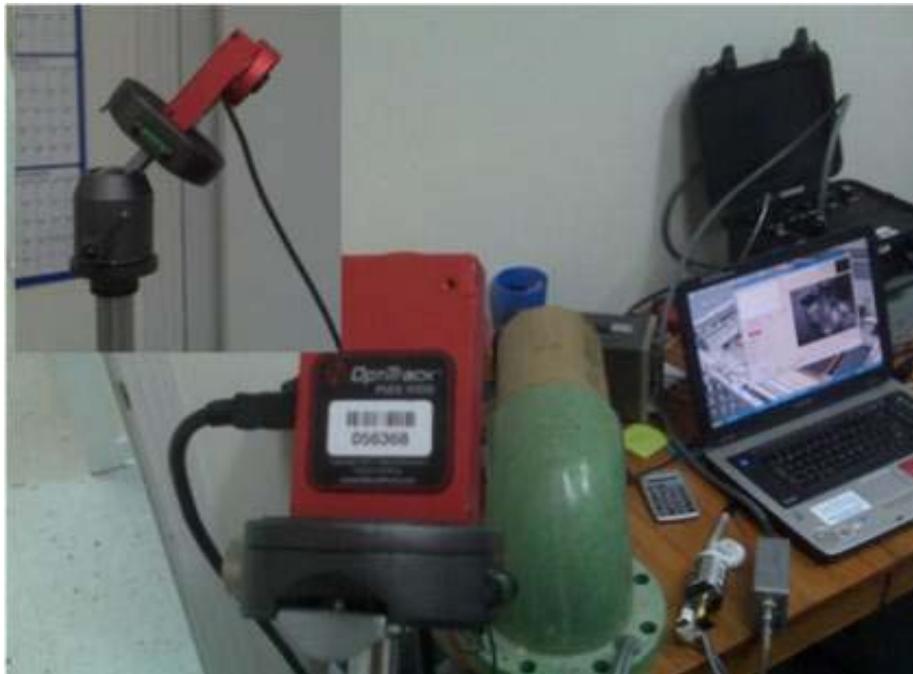
Figure 4: Position Tracking System

The Tracking System used for field applications with manual probe manipulation is shown in Figure 4, where it is set up in the laboratory for scanning a piece of FRP pipe elbow. The position tracking system uses an OptiTrack IR camera to follow the probe position. Position data is fully integrated with Evisive Scan TM control and data presentation software. Some data was collected with a stationary x-y plotter table in the laboratory.

Calibrated position measurements can be made from the microwave image, enabling analysis of observed artifacts. The Evisive Scan image was made using the scanning table, with access from one surface only. The part was backed with $\frac{1}{4}$ inch steel. Alternative positioning means such as the IR Tracking system illustrated in Figure 4 (replacing the scanning table) have been demonstrated for field use.

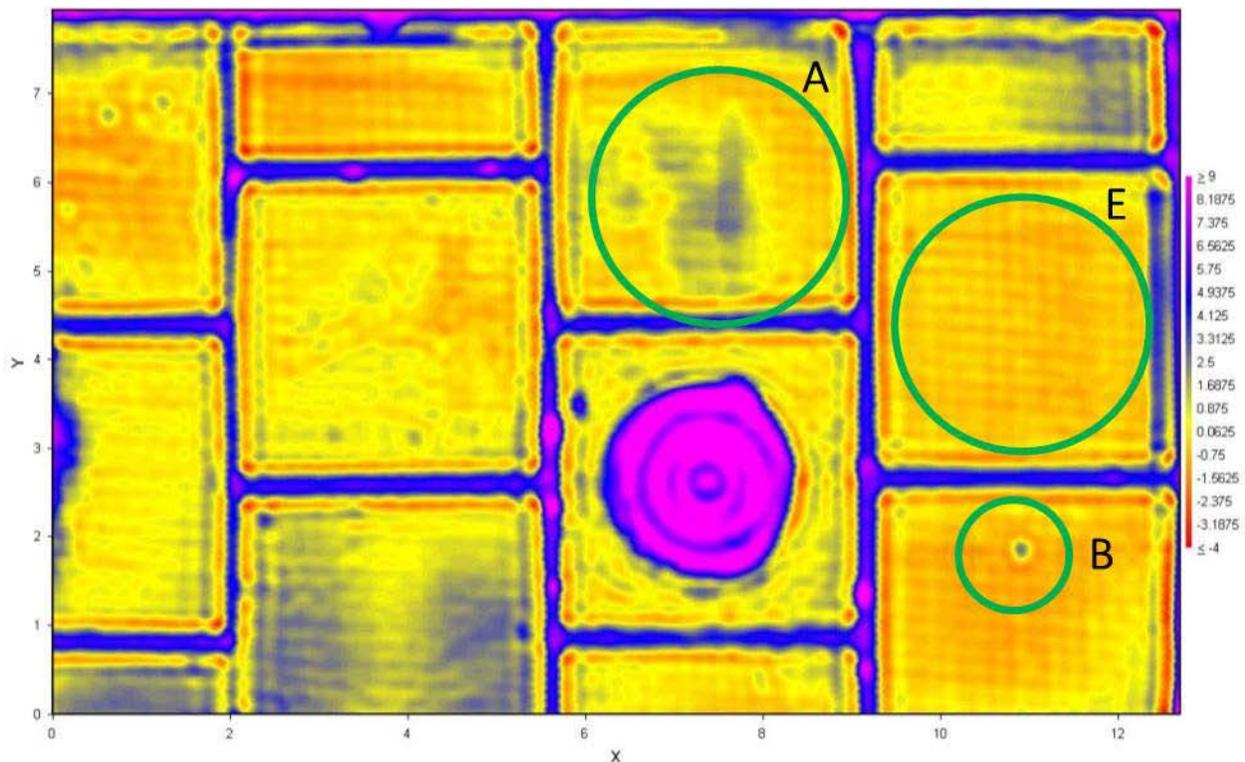
Figure 7: Specimen Panel Scan Channel A

The following figures illustrate detection and imaging of features in the ceramic composite material other than cracks in the tiles. Figure 7 is a false color presentation of Channel A data from the scan of the panel shown in Figure 5. The color spectrum associated with data voltages is shown at the right of the image.

The large round feature is a mounting hole machined through the panel. As described in Evisive Scan Methodology, and illustrated in Figure 2, this Channel A image represents the maximized phase differential at a specific depth in the material which is imaged.

Based on comparison to images of other samples, the feature identified as A is likely to be an interlayer disbond in the encapsulating material. The feature identified as B is likely to be a void in the encapsulating resin or interlayer material. The relative depth of this feature is indicated by the presence of an interference ring (the yellow ring surrounding the blue center). Similar features in the center and upper left are unlabeled.

The regular pattern labeled E in Figures 7, 8 and 9 is the lay of fiber in the encapsulating material. The near and far surface fiber matrices can be differentiated by the relative response in the separate Channels. This fiber pattern is apparent in Channel A, B and composite Channel C images. The fiber ribbons themselves are on
