ICONE17-75742

MICROWAVE BASED NDE INSPECTION OF HDPE PIPE WELDS

Robert Stakenborghs

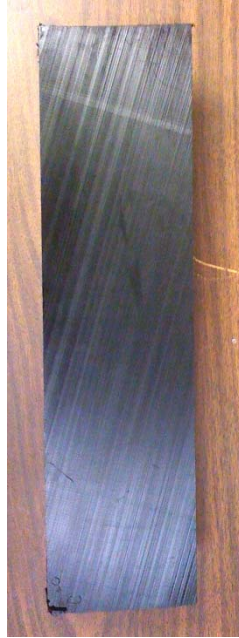
Figure 1
HDPE Weld Block

In order to further understand the microwave technique and its ability to fully interrogate the HDPE weld, a method was needed to determine if the heat affected HDPE material near the weld indeed had properties that allowed the technique to distinguish it from the base material. The most effective way to accomplish this was to scan a defect free HDPE thermal fusion weld that had been machined flat on each surface. This would eliminate any surface features (including weld beads) that might skew the data due to geometry factors. Such a block was fabricated by Acuren and delivered for scanning. The block is shown in figures 1 and 2.

The weld was cut out from a thick section of HDPE pipe and shaped into a 3.5” by 4” block. The sides were machined smooth so there are no surface features and no inner or outer beads. Figure 2, the weld close-up, shows that the weld line is barely discernable from the base material.

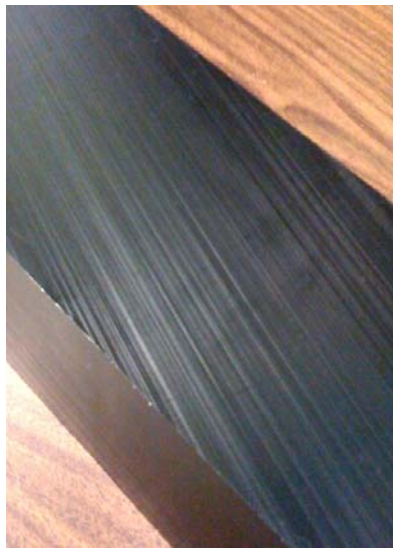
Figure 2
Close-up of HDPE Weld Block Showing Weld Location
