Imaging Corrosion and Pipe Surface Features Beneath Coatings Using Evisive Scan™ Technology

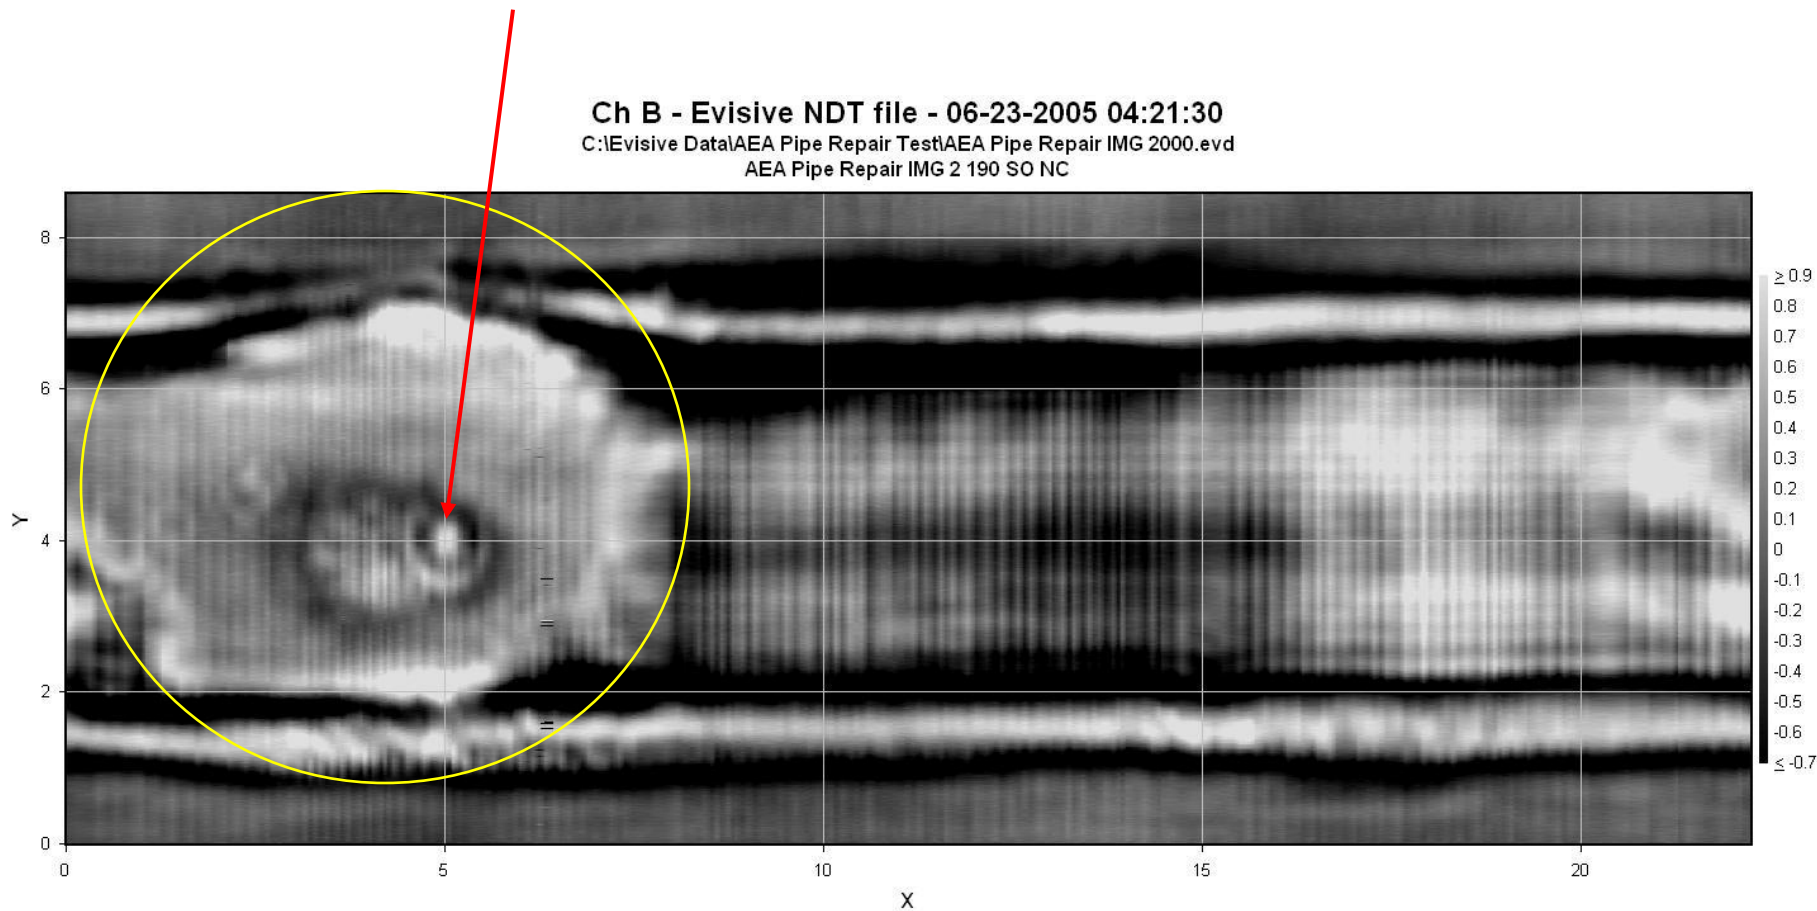
In this example, a hole was drilled in the pipe wall, and a small teflon disk was placed over the hole. A commercially available over-wrap repair technology was then used on the pipe. After repair application, the pipe was pressurized until the repair failed, allowing fluid to escape. The hole and teflon disk was located at (5,4) in this scan. The area where fluid disbonded the repair can clearly be seen, and is circled in yellow. The fluid escaped from under the wrap at (4.5,7), as indicated by the red arrow. The wrap remains properly bonded from X=8 to approximately X=21, where the water induced disbond begins.
