Specific Application NDE Method Leads to Development of Novel Microwave NDE Technique

By **Bob Stakenborghs**, PE, Evisive, Inc.

Microwave NDE Technique – Testing of FRP and PE Piping – Examples

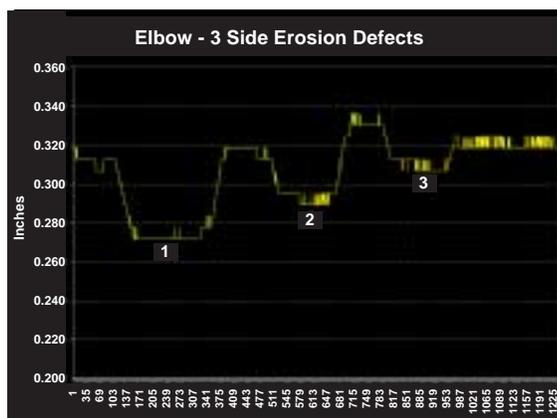
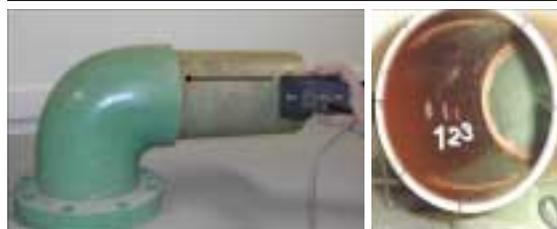
Figure 4.

Figure 4 shows a similar fiberglass pipe with three mechanically produced side wall defects of varying depth. Again, the microwave scan accurately indicates the depth, or amount of removed material, at each defect location.

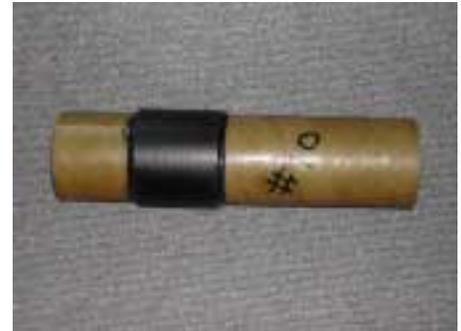
Figure 1.

As part of the proof of principle testing for this method, several samples of fiberglass piping and joints were provided by various end users and examined. The following photograph (Figure 1) shows one of the samples that was provided.

Figure 1 shows a sample that consisted of two 4 inch fiberglass (FRP) pipes joined by a glued coupling. The coupling was a fiberglass casting, which did not have any glass reinforcing. The joint had been made with insufficient glue

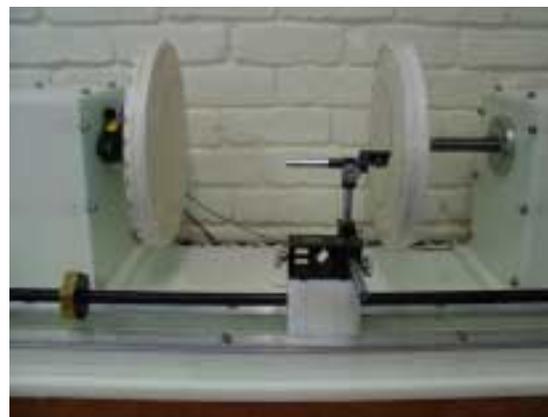
Figure 4.

In order to process the increasingly large number of samples in a timely fashion, a "scan lathe" was developed for laboratory use. The scan lathe rotates the sample while scrolling the microwave probe down its length. The scan lathe is shown in figure 4. The sample is placed between the two end plates. A typical scan time for a 4 inch nominal diameter pipe is less than 5 minutes.

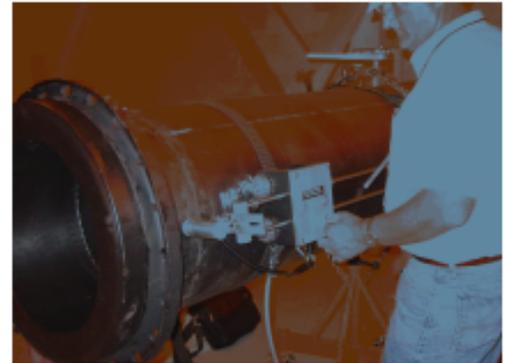
Figure 6.

In order to make to method useful, a means was required to allow piping inspection in field applications. A field inspection device was developed, which allows scanning of pipe in a fashion similar to portable ultrasonic inspection equipment. Figure 6 shows a typical field inspection installation.

Basic Field Scanner Setup

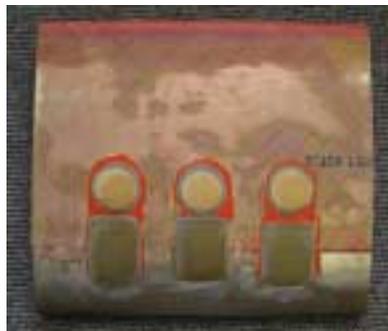
Figure 5. Photograph of aircraft composite rotor with embedded defects.

aircraft rotor. Figure 5 is a photo of a piece of the rotor with known embedded defects. Figure 6 is a microwave scan taken from the top side of the rotor. It clearly shows

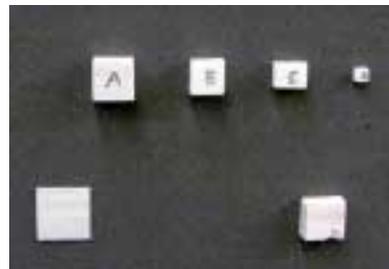
Figure 13. Location of intentional defects in Spray On Foam Insulation Coupon, prior to application of 4 inches of insulation.

Figures 13 and 14 are of a prepared coupon of a spray-on foam insulation (SOFI). Figure 13 shows the coupon prior to the application of the spray-on foam, indicating the location and types of defects. The scan image in figure 14 clearly shows all of the defects. Note that the scan image retains the geometric configuration of the defects. The defect in the right lower corner of the image represents a roll-over defect, where various passes of foam have a defect at the seam between passes. The other defects represent voids and delaminations. Detection and location of defects in this SOFI material is currently of some considerable interest to NASA.

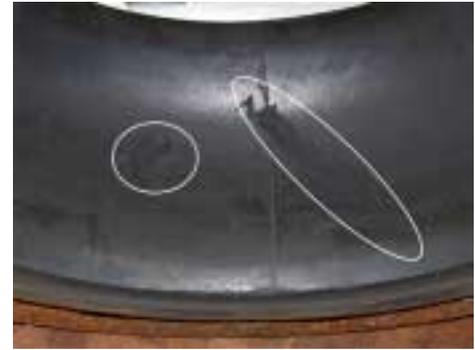
Figure 15. Interior of a rubber piping expansion joint showing intentional defects and "Mold line".

Figure 15 and 16 are of a rubber piping expansion joint. Figure 15 is a picture showing intentionally embedded defects. The defects have been emphasized in the close-up photograph by surrounding them in white.
