PVP2006-ICPVT11-93795

INNOVATIVE TECHNIQUE FOR INSPECTION OF POLYETHYLENE PIPING BASE MATERIAL AND WELDS AND NON-METALLIC PIPE REPAIR

Robert J. Stakenborghs
Evisive, Inc.

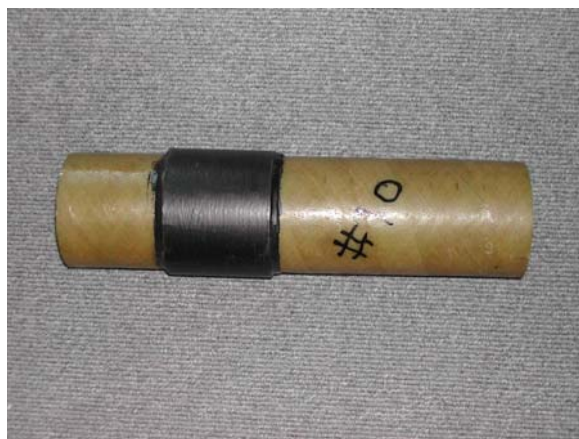
Figure 1

Fiberglass Pipe Coupon Photograph

Fiberglass Pipe Coupon

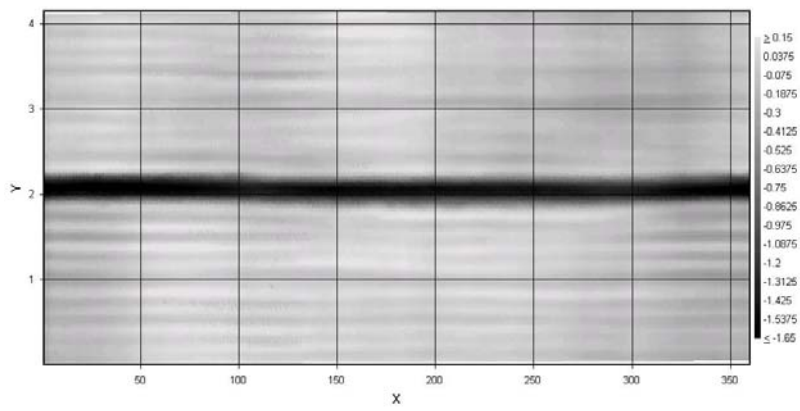
Figure 5

Gray Scale Scan of a PE Pipe Weld with No Known Defects

Figure 4 and 5 are scans of a small bore (4 inch) PE pipe with a thermal weld that contains no known flaws. Note the minimal voltage variation along the length of the weld from X = 0 to 360 degrees. Also note that the weld appears uniform across its length and is symmetric from side to side. These are characteristics of a weld with no flaws.

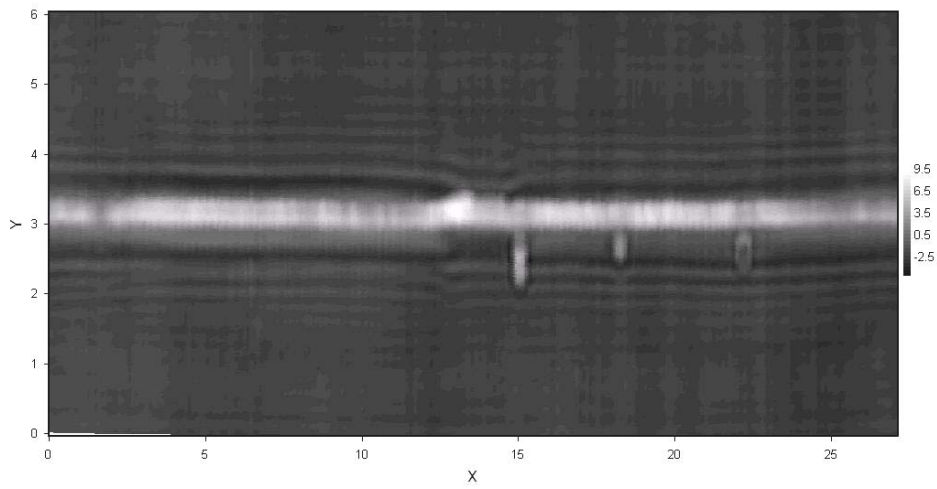
Figure 7
Gray Scale Scan of a PE Pipe Weld with Multiple Known Defects

Figures 6 and 7 are scans (color and gray scale respectively) of a coupon that was manufactured from a piece of 8 IPS, DR17 "Driscoplex" HDPE pipe manufactured with a thermal butt fusion weld with 7 individual intentionally embedded defects. The coupon was created as follows;

It should be noted that the intentionally cooled region, centered on $X = 11.75$, was cooled so severely that a significant deformation of the inner bead resulted. This deformation can be seen as the wide red region from $X = 11.5$ to $X = 13$ in figure 6, and also is responsible for the curved interference fringes at these same X locations, but at Y locations corresponding to $\frac{1}{2}$ wavelength offsets. Note that the inner bead interference fringes are elsewhere parallel and continuous. All defects were detectable.

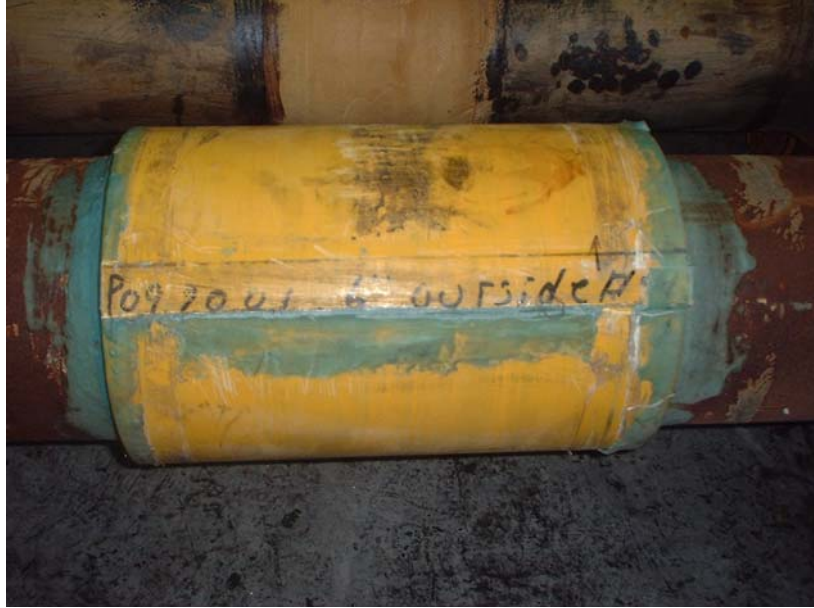
Photograph of Pipe Repair (Clockspring®)

Figure 10 is a photograph of a Clockspring® pipe repair coupon. This repair consists of fiberglass layers with epoxy filler between the layers. The coupon was prepared by drilling a 5 mm hole in the pipe and applying a Teflon cover over the hole. The repair was applied over the Teflon cover. Once the repair was completed and cured, the piping was pressurized to fail the repair. This pressurization typically resulted in the repair becoming dis-bonded from the piping at the repair/piping interface and a leak path being created to the edge of the repair. Figure 11 is a scan of this repair. The dis-bond can be seen in the repair in the region of $X = 5$ to 10 and $Y = 0$ to 2 . A patch can be seen in the scan from $X = 8$ to 12 and $Y = 2$ to 6 . Also, several round indications that are potentially the drilled hole appear in the region between $X = 7$ and $Y = 2$ to 5 . All defects were detected.

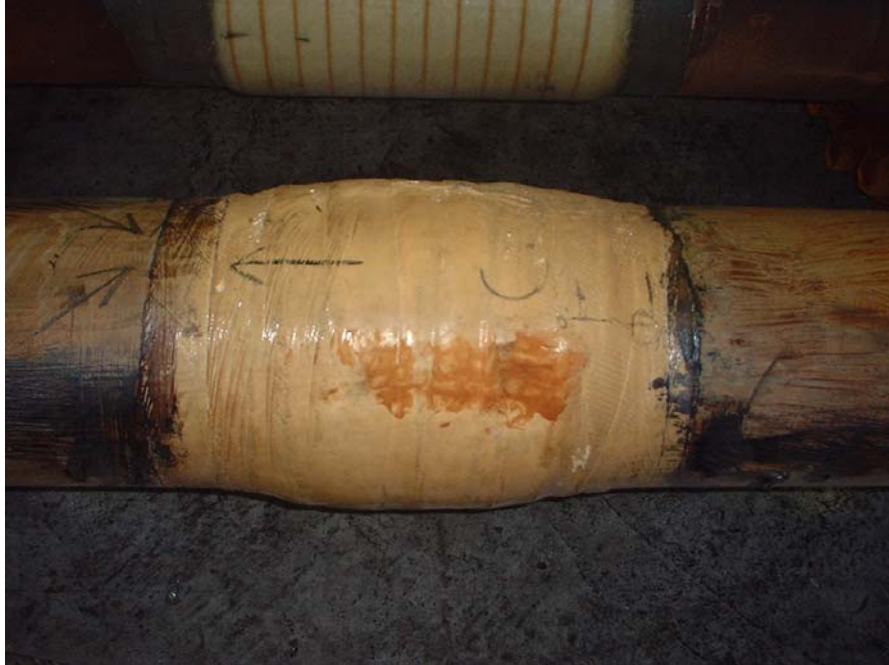
Figure 12
Photograph of Pipe Repair (IMG)

Figure 12 is photograph of another brand of pipe repair, manufactured by IMG. This repair is made by applying fiberglass cloth impregnated with resin. The coupon was prepared in the same fashion as the Clockspring® repair coupon described previously. Figure 13 is the scan of this repair. Note the rounded indication located at $X = 5$ and $Y = 4$, which is clearly the 5 mm hole and Teflon cover. Also, the region defined by $X = 0$ to 8 and $Y = 2$ to 6 is the area disrupted by the pressurization. The area of the repair at $X = 5$ and $Y = 8$ is where the repair ultimately failed and leaked. All defects were detected.

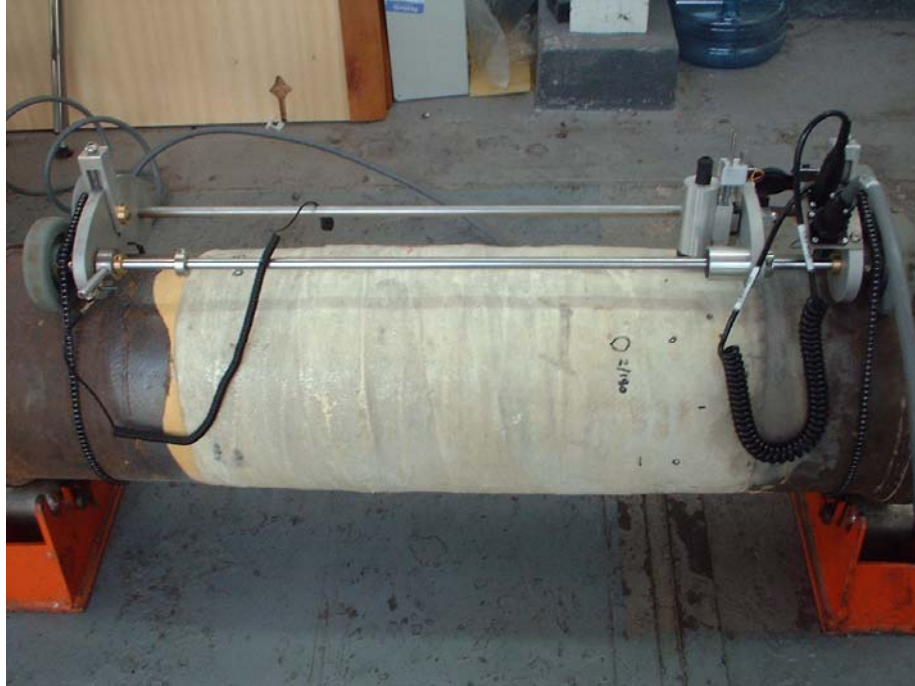
Photograph of Fiberglass Pipe Repair Showing Field Microwave Inspection Device

Figure 14 is a photograph of a third type of pipe repair. Included in this photograph is the manual microwave inspection device used for these inspections. This repair is made by the application of resin impregnated fiberglass cloth wrapping around the pipe. This repair was intentionally applied over a section of piping that had been removed from service due to surface corrosion in the form of localized pitting. The scan, seen in figure 15, clearly shows the location of the pipe surface corrosion under the repair, which appear as the dark areas in the scan. As can be clearly seen, the major pitting occurs at $X = 18$ to 25 and $Y = 16$ to 22 . Minor pitting is also evident as dark areas in the other regions of the scan.

In order to make the method useful, a means was required to allow piping inspection in field applications. Several manual field inspection devices were developed, which allow scanning of pipe in a fashion similar to portable ultrasonic inspection equipment. Figures 14 and 16 are photographs of two types of manual field inspection devices, or scanners. Currently, automated scanners have been developed and also are in use. Scan time varies from application to application but are typically on the order of 5 to 10 minutes per square foot. The method requires access to only one side of the specimen and does not require direct contact. As such, no liquid or other couplant material is required.
