# NEW METHOD TO DETECT COLD FUSION JOINTS IN HIGH DENSITY POLYETHYLENE PIPE

*Robert Stakenborghs, General Manger, Evisive, Inc. Baton Rouge, LA*

## Abstract

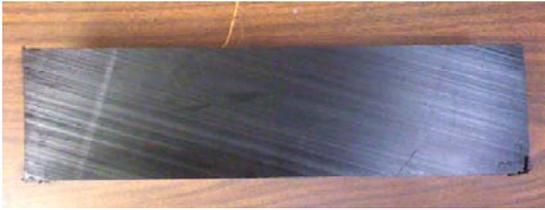
The block is shown in figures 1 and 2. This particular thermal fusion was cut out from a thick section of HDPE pipe and shaped into a 3.5” by 4” block. The sides were machined smooth so there are no surface features and no inner or outer beads. Figure 2, the fusion close-up, shows

that the fusion line is barely visually discernible from the base material.

Figure 1. HDPE Butt Fusion Block

Figure 2. Close – up of HDPE Block Fusion Zone

In order to verify that supposition that there is a difference between the dielectric properties of the heat affected HDPE material near the fusion and the base material, and that it is detectable, a simple test was developed. It seems clear that the theory would be proven if a defect free HDPE thermal fusion could be detected and differentiated from the base material. In order to remove other possible indicators, the sample was machined flat to remove any surface irregularities that might affect the data. Eliminating any surface features (including fusion beads) eliminates the possibility of skewing the data due to geometry factors.

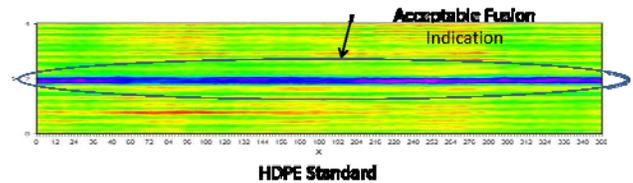
Figure 4 – HDPE Acceptance Standard

Figure 4 illustrates an example of a known good fusion. In this image, the X axis is the pipe diameter and the Y axis is a length of pipe that contains the fused zone. The fused zone is located at the center of the image (Y=2) from X=0 to X=360 degrees. The colors are false color representations of the voltage scale. The recorded voltage, as you may recall from previous discussions, is the result of the presence of materials of differing dielectric constants that pass under the transceiver.

An acceptable fusion has, therefore, been shown to be one where the difference between the fused zone and the base material results in a very clear unbroken change in voltage from the base material. This is very clear in the image shown in Figure 4.

In order to perform an adequate inspection, acceptance criteria were developed for HDPE thermal butt fusions. The acceptance standards are based on inspection of many hundreds of acceptable and flawed specimens. In some cases, the specimens were mechanically tested to verify their mechanical properties.

The acceptance criteria is illustrated in figure 4.

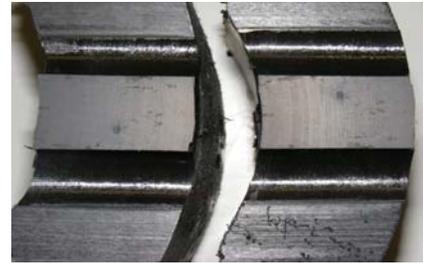
Figures 7 and 8 show that both joints failed had brittle fracture results for the tensile test, and thus failed the test. In fact a close-up of a Joint 1 section, shown in Figure 9, shows a very smooth brittle fracture site with no trace of ductility. These joints clearly fall into the “failed” category, as described by the WIS criteria, and could easily have failed in service.

Figure 9 – Tensile Test Result Joint 2 Close-up

Similarly, a second poor quality joint, as seen in the field inspection image in Figure 6, was selected. These were determined by the inspection to be the two worst quality joints. These joints were cut into sections and the fusion zones were mechanically tensile tested in accordance with Appendix B of WIS 4-32-08. The results of the tensile testing are shown in figures 7 and 8.
