ICONE17-75602

A MODERN APPROACH TO CONDITION-BASED MAINTENANCE OF REINFORCED RUBBER COOLING SYSTEM EXPANSION JOINTS UTILIZING A MICROWAVE NON-DESTRUCTIVE INSPECTION METHOD

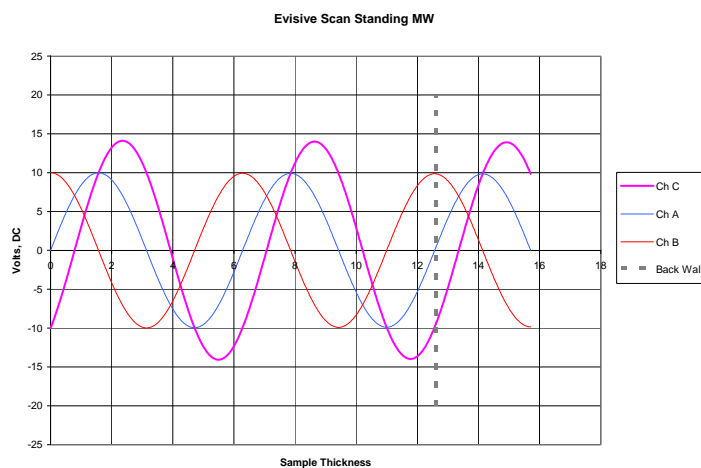
Figure 1 below represents the virtual standing waves in the inspected part created by a single microwave emitter and two detectors which are separated in the axial, or “Z” dimension by $\frac{1}{4}$ wavelength ($\frac{1}{4} \lambda$). The two results of this hardware configuration are two virtual standing waves, offset by $\frac{1}{4} \lambda$ through the thickness of the part. The amplitude of the virtual standing waves in Figure 1 are proportional to the expected detector voltage (with the constant of proportionality being the gain setting) which would result from moving the specimen back wall (dashed line) to that position.

FIGURE 1: STANDING MICROWAVE

It is clear from the figure that, if using a single detector, there are regions where a substantial change in back wall position will result in very little change in detector voltage. These are referred to as regions of low intrinsic sensitivity. They occur where the first derivative of the virtual standing wave approaches zero, when either transitioning from positive to negative or negative to positive. In a dual-detector arrangement, with the detectors staggered in “Z” by $\frac{1}{4} \lambda$, the region of low intrinsic sensitivity for one detector corresponds to a region where the first derivative of the virtual standing wave for the other detector is at its maximum. Arranging the detectors in this way ensures that a defect of interest will always be detected by at least one of the hardware channels, because a defect which escapes detection by one channel must, by definition, occur at the position of maximum sensitivity for the other. A “C” channel, or mathematical construct channel is also plotted in Figure 1. It represents the arithmetic difference between the two available hardware channels. It can be used to highlight defects and inhomogenities associated with a particular, relatively limited thickness range in the inspected part. Such defects, including delaminations and disbonds will

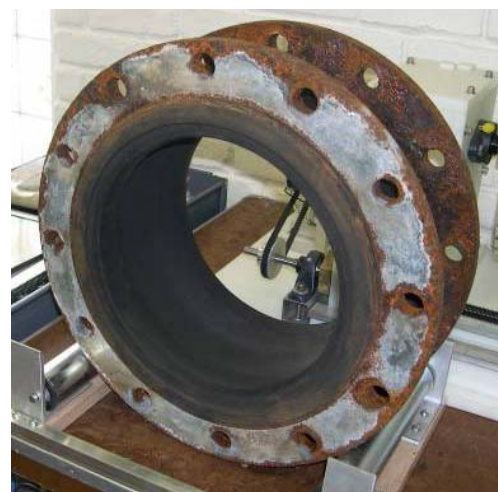
In order to ascertain whether the proposed microwave method could be used effectively for in-field inspection of rubber expansion joints, first a laboratory mock-up must be developed. The laboratory environment permits a modicum of control over parameters which are typically far more difficult to control in a commercial power plant. These parameters include temperature, humidity, cleanliness and the quality of available AC power. This mock-up was developed utilizing a rubber joint which had been removed from a commercial nuclear power plant after several years of service. The joint was twelve inches nominal pipe size and approximately eight inches long. This joint is manufactured from multiple layers of synthetic fabric (the pressure-retaining or structural sub-component) surrounded on both the inner and outer diameter by a rubber “jacket” or “tube” which protects the inner “carcass” from the outside environment and the process fluid within. A fixture was developed to move the microwave transducer the full 360° around the circumference of the joint, and then permit a small axial motion before reversing the circumferential motion and repeating. This scan-and-raster arrangement is typical of the devices used commercially to scan a right circular cylindrical shape while performing NDE (for example, a pipe weld). The device records its position in orthogonal coordinates, such as (X,Y) or (R,θ) using optical encoder devices. These locations are associated with the appropriate detector voltages and the data is then used to create an image. A photograph of the expansion joint used in the lab mock-up is shown in Figure 2.

FIGURE 2: EXPANSION JOINT MOCK-UP

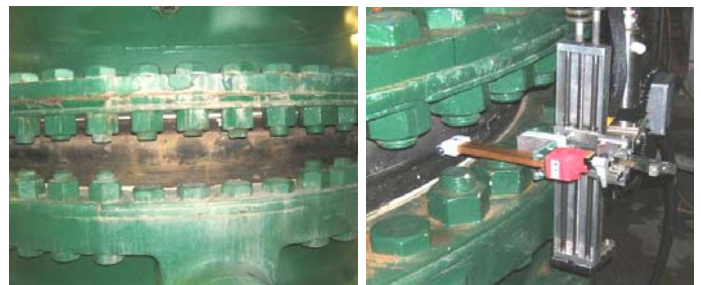
Having been proven feasible in a laboratory environment, the microwave NDE method was applied to cooling water expansion joints in a commercial PWR nuclear unit in the United States. The PWR environment was selected because of its lack of ionizing radiation and radioactive contamination challenges. This approach permits the further development from a laboratory method to a true field method in a setting where the task is less time-critical than would be the case in a Boiling Water Reactor (BWR) type plant. For the pilot PWR project, twelve cooling water expansion joints were chosen for inspection. These were located on the inlet and outlet cooling water lines for each half-section of a 3-section main steam surface condenser. These joints were each 138 inches in diameter and approximately 8 inches long. These joints were scanned with the system in service and full of water using a modified commercially available industrial robot. Both a representative joint and the scanning robot can be seen in Figure 5.

FIGURE 5: EXPANSION JOINT WITH SCANNING EQUIPMENT

This scanner steps (rasters) incrementally around the circumference of the joint while scanning axially between steps. The image is created in the same way as before. Images of an unconditionally acceptable joint and a conditionally acceptable joint appear in Figure 6. This particular manufacturer of expansion joint utilizes a different approach to fabrication than did the manufacturer of the previous, smaller joint scanned in the lab mock-up and described in that section. In the joints currently under discussion, strips of fabric,

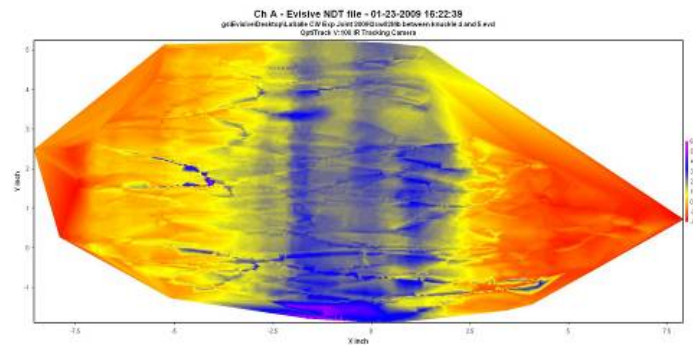
morphology of the detected irregularity. The resulting image is shown in Figure 9.

The image in Figure 9 has been displayed in “false color”, where a color gradient from magenta to red has been associated with a voltage gradient from minimum to maximum voltage, respectively. The irregularity or feature imaged in Figure 9 is, again, the overlapping of the cover rubber, characteristic of the manufacture of these components and does not represent a defect or flaw.

FIGURE 9: RESULTING IMAGE USING IR CAMERA

During the BWR expansion joint inspections, several indications were encountered during time domain line scanning which required IR camera imaging to determine the
